# Barry Buddon First World War Training Trenches

Archaeological Evaluation: Data Structure Report

Ref: 117440.01  
October 2017

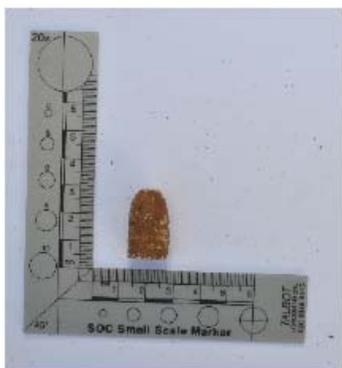
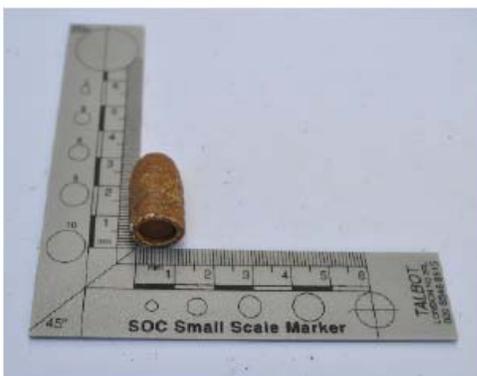
**Type:** .577 Snider bullet

**Date:** Unknown (introduced in October 1868).

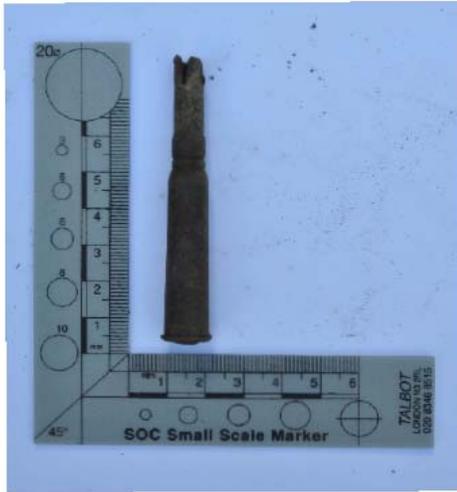
**Type:** Cartridge S.A., Blank, .303-inch. With Mock Bullet (fired)

**Date:** Undated - Introduced 1907

**Manufacturer:** Royal Laboratory, Woolwich

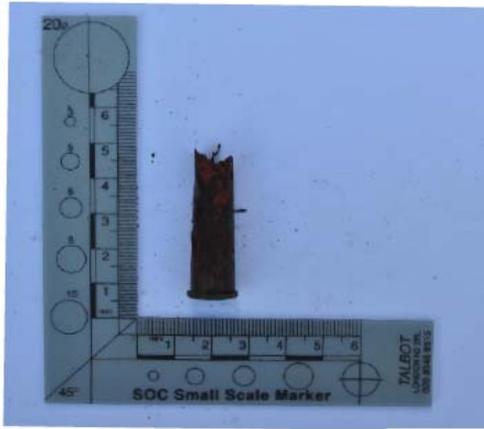
**Type:** Cartridge S.A, Blank .303-inch.L Mark V. LNA. For carbines or rifles (fired)

**Date:** 1911

**Manufacturer:** Royal Laboratories, Woolwich

**Note:** Manufactured using ball case. Identification as blank made from visual analysis of struck primer .

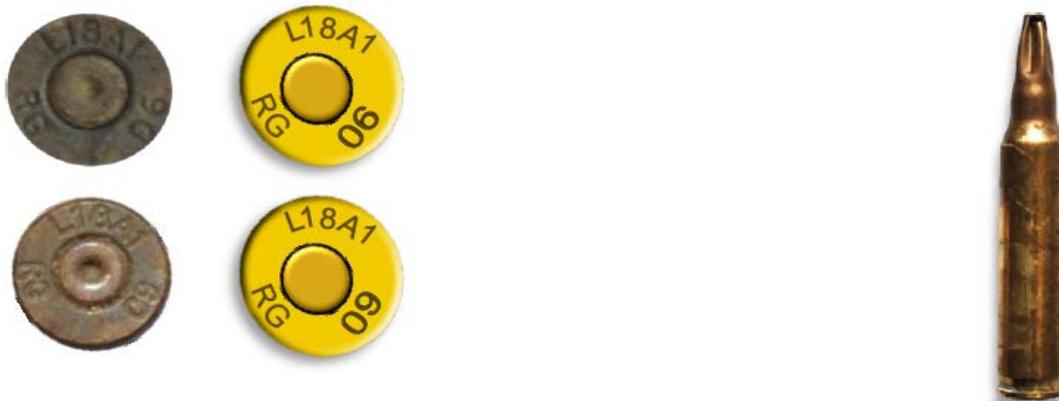
**Type:** Cartridge blank 5.56 L18A1 (fired)  
**Manufacturer:** Radway Green

**Country of Origin:** United Kingdom  
**Notes:** Examples dated 2006 - 2009

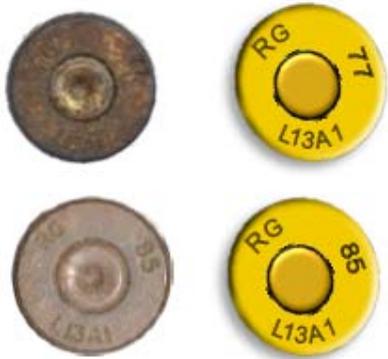
**Type:** Cartridge blank 7.62 L13A1 (fired)  
**Manufacturer:** Radway Green  
**Country of Origin:** United Kingdom  
**Notes:** Examples dated 1977 & 1985

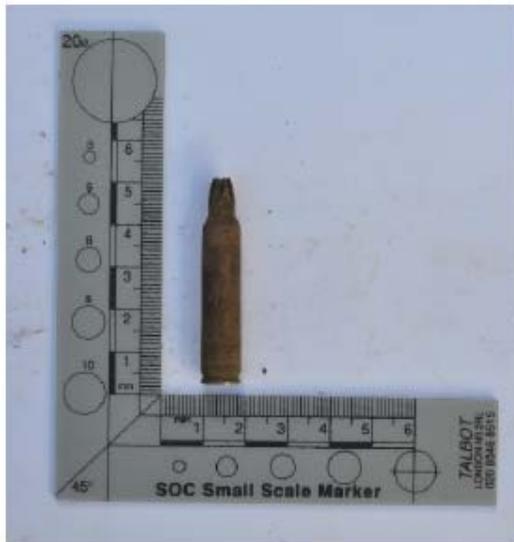
**Type:** 5.56mm M200 blank (fired)

**Manufacturer:** Lake City Ordnance Plant, Missouri, USA

**Note:** Headstamp showing date not legible.

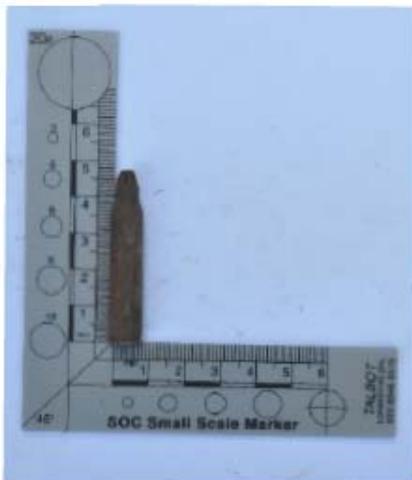
**Type:** 5.56mm M200 blank (fired)

**Manufacturer:** Lake City Ordnance Plant, Missouri, USA

**Note:** Headstamp showing date not legible.

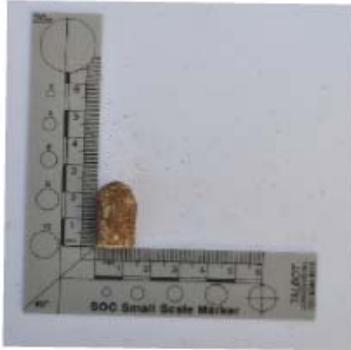
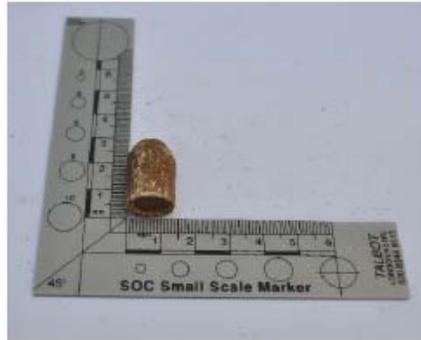
**Type:** .577 calibre muzzle loading rifle bullet

**Date:** Unknown (consistent with the .577 Enfield bullet, pattern of 1859).

**Note:** Bullet features 5 groove right hand twist rifling and has a clay plug in base. Ramrod mark evidenced on nose of bullet. Whilst is not possible to categorically match this bullet to a specific rifle, the probability is that it was fired by an 1853 type muzzle loading rifle. Weight: 53.087 grains. Length 0.933 inches (23.7mm). This is consistent with the .577 Enfield bullet, pattern of 1859.

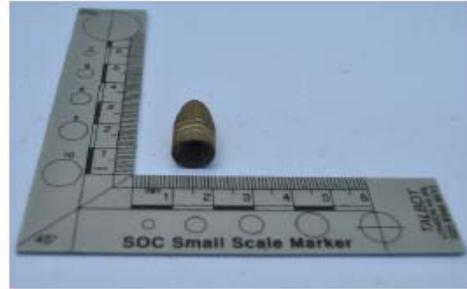
**Type:** Webley .455" MK I Revolver bullet

**Date:** Unknown (approved in July 1891)

**Notes:** Bullet evidences x5 groove right hand twist rifling. This is indicative of having been fired by a Smith & Wesson Hand Ejector Model Revolver. Large numbers of these revolvers were purchased by the British government for use during the First World War.

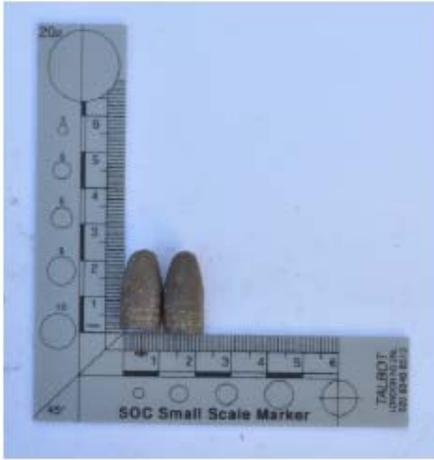
**Type:** Webley .455" MK I Revolver bullets

**Date:** Unknown (approved in July 1891)

**Notes:** Bullet evidences x7 groove right hand twist rifling. This is indicative of having been fired by a British Webley revolver.

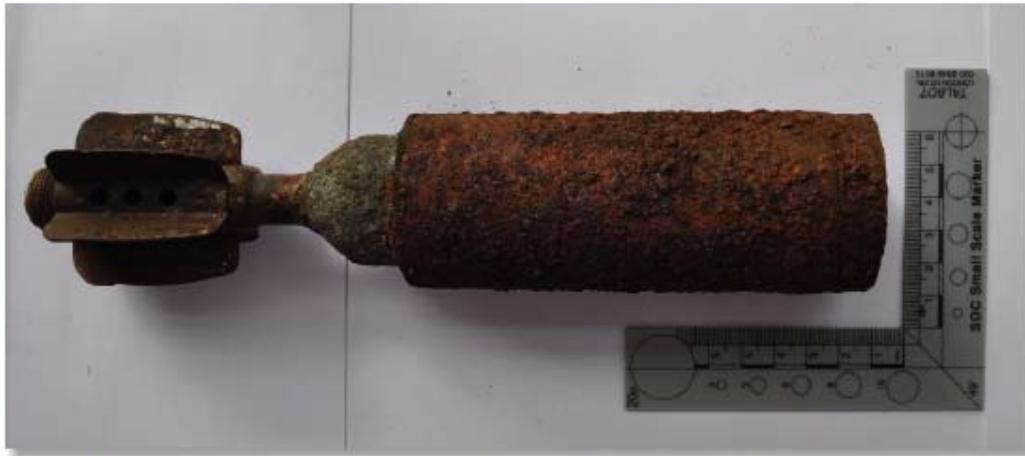
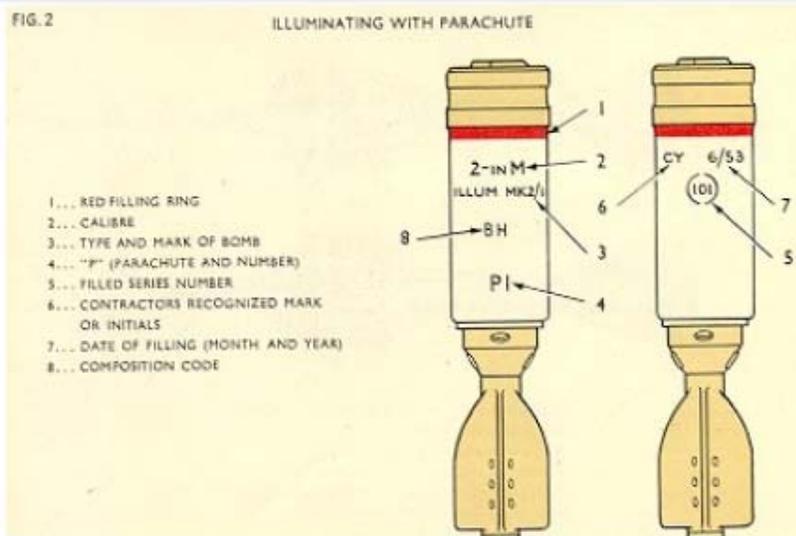
Trench Two - Mortar Bomb

**Type:** Bomb,M.L.,Illuminating,with parachute. 2-inch Mortar (fired)

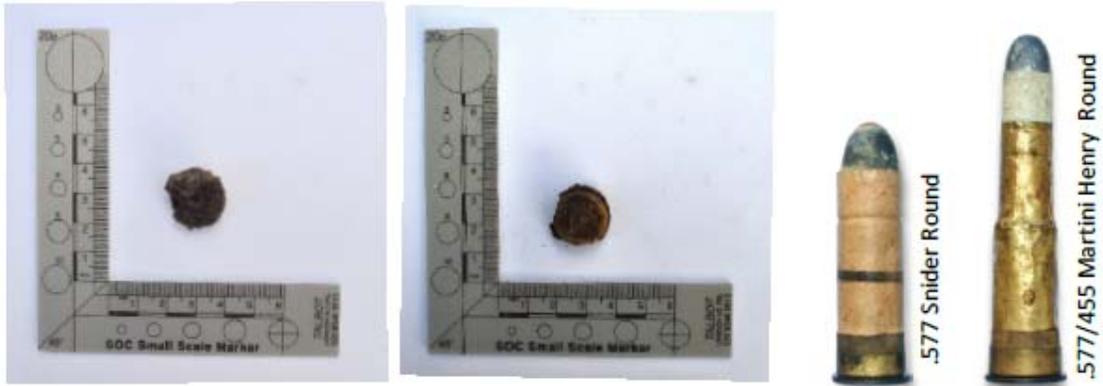
**Type:** Base of a 577 Snider or 577/455 Martini Henry cartridge

**Date:** Unknown (.577 Snider introduced in October 1868. .577/455 Martini Henry introduced in June 1872)

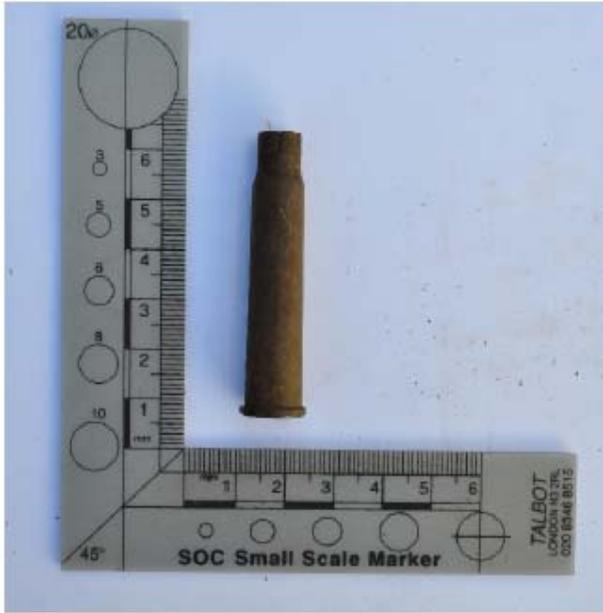
**Type:** Cartridge S.A., Blank, .303-inch. L Mark 9 Z.

**Dated:** 1960

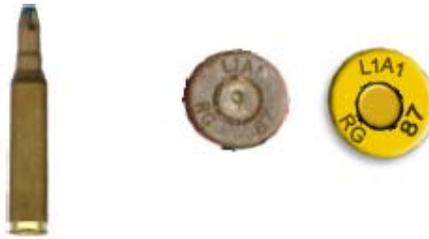
**Type:** Cartridge blank 5.56 L1A1 (fired)  
**Manufacturer:** Radway Green  
**Country of Origin:** United Kingdom  
**Notes:** Example dated 1987

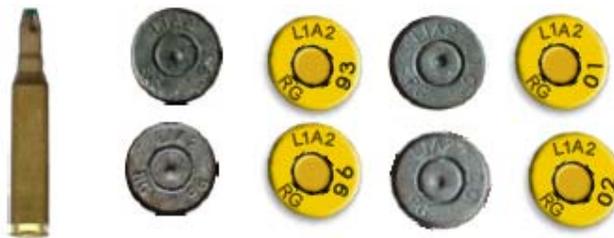
**Type:** Cartridge blank 5.56 L1A2 (fired)  
**Manufacturer:** Radway Green  
**Country of Origin:** United Kingdom  
**Notes:** Examples dated 1993 - 2002

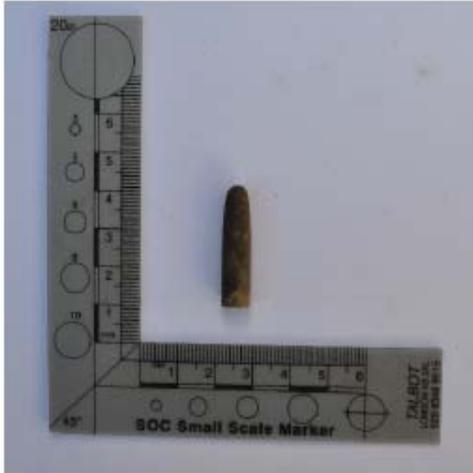
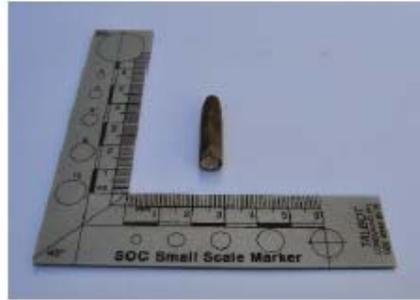
**Type:** Bullet. .303-inch Mark I.C or Mark II. C

**Date:** Mark 1. C introduced 1-12-1889. Obsolete: 1-9-1894 Mark II. C Introduced 1-11-1890. Obsolete: 1-9-1912

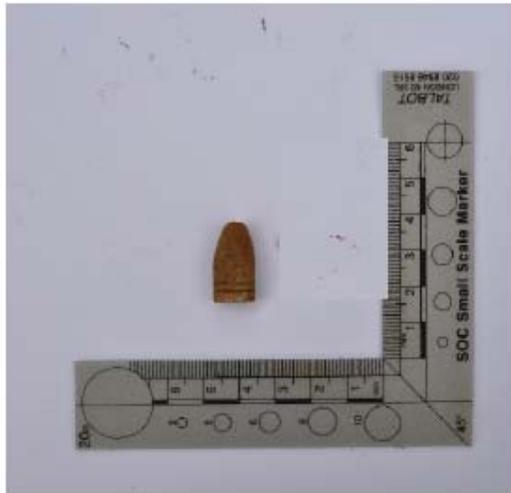
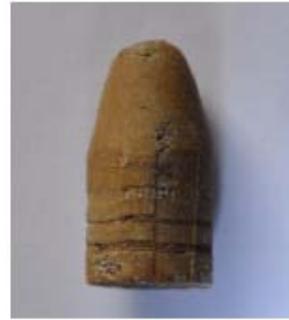
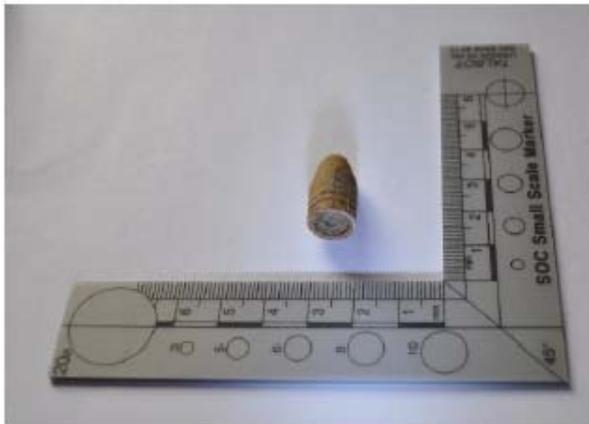
**type:** Webley .455" MK I Revolver bullet  
**Dated:** Unknown (approved in July 1891)

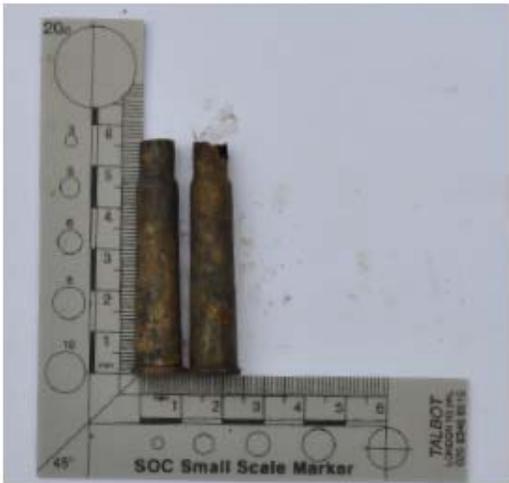
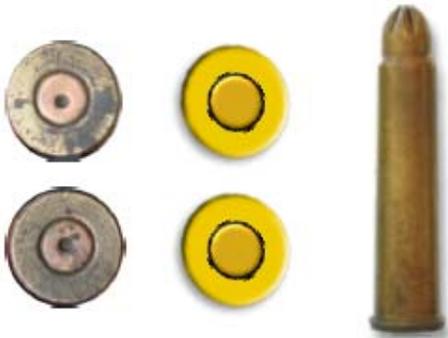
**Type:** Cartridge S.A., Blank, .303-inch. L Mark 9 Z.

**Notes:** No Headstamp - consistent with Second World War manufacture.

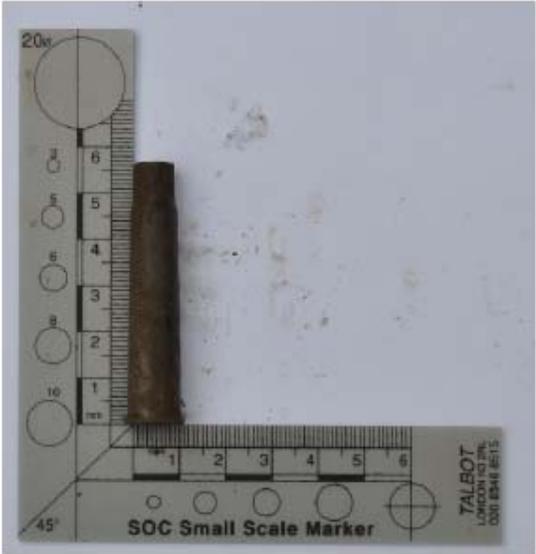
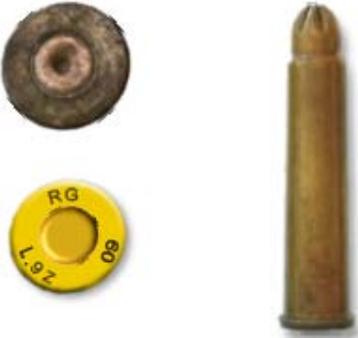
**Type:** Cartridge S.A., Blank, .303-inch. L Mark 9 Z.

**Dated:** 1960

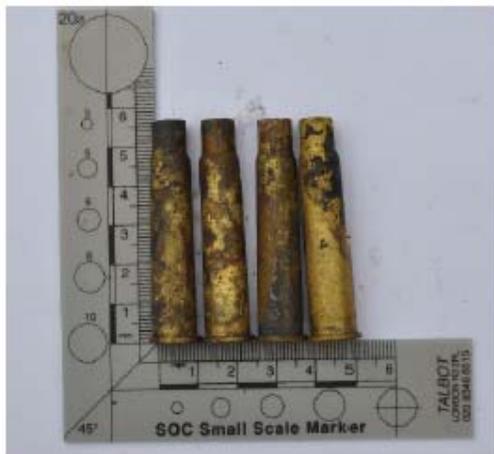
**Type:** Cartridge S.A., Blank, .303-inch. L Mark 10 Z.

**Manufacturer:** Radway Green

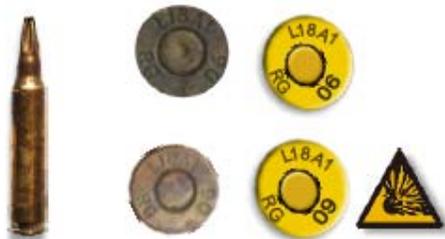
**Type:** Cartridge blank 5.56 L18A1 fired & Live.

**Manufacturer:** Radway Green

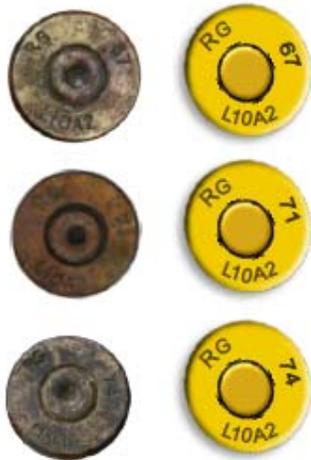
**Type:** Cartridge blank 7.62 L10A2 (fired)

**Manufacturer:** Radway Green

**Notes:** Examples dated 1967 - 1974

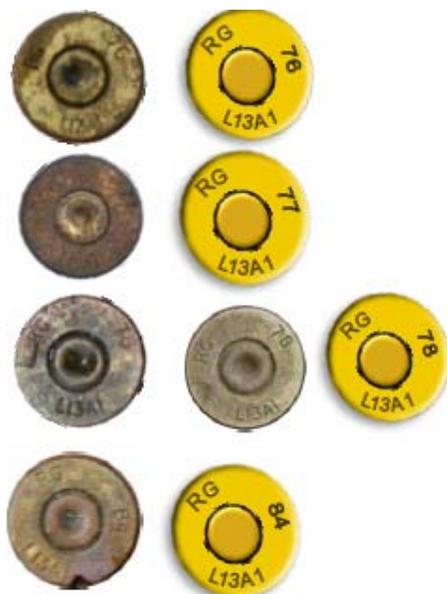
**Type:** Cartridge blank 7.62 L13A1 (fired)

**Manufacturer:** Radway Green

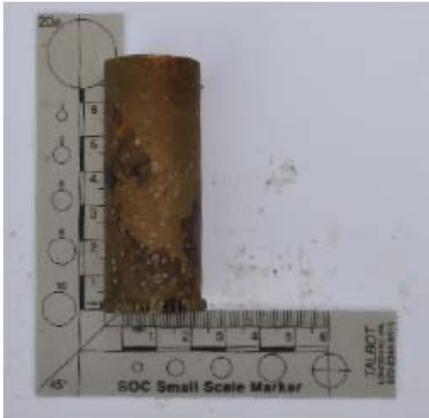
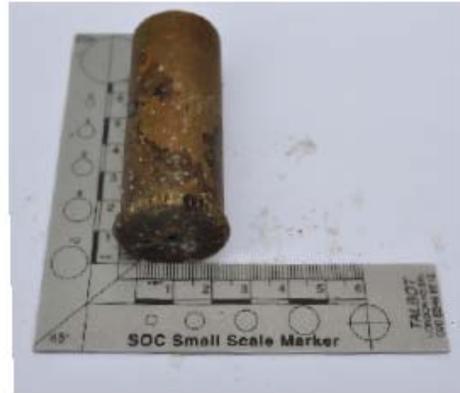
## Trench Seven – Miscellaneous Ammunition

**Type:** Cartridge, Signal, 1- inch, White Signal (fired)

**Notes:** Base of cartridge milled half way round, indicating white. Base of cartridge marked 'RG/7/74'

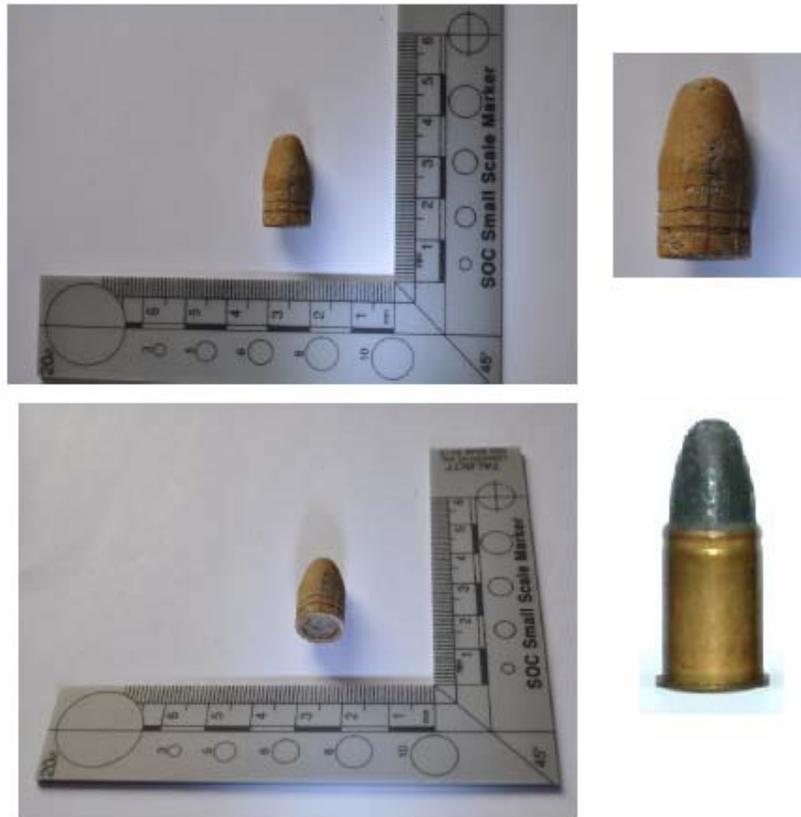
# Trench Seven – Bullets

**Type:** Webley .455" MK I Revolver bullet

**Dated:** Unknown (approved in July 1891)

**Notes:** Bullet evidences x5 groove right hand twist rifling. This is indicative of having been fired by a Smith & Wesson Hand Ejector Model Revolver. Large numbers of these revolvers were purchased by the British government for use during the First World War.

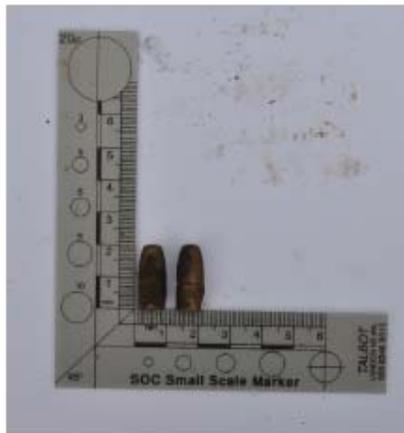
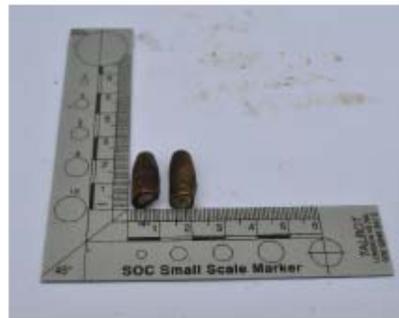
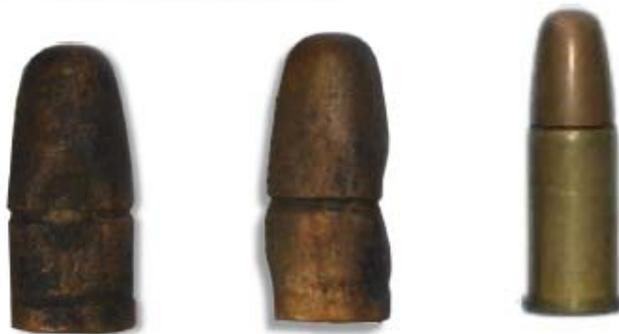
# Trench Seven – Bullets

**Type:** .380 inch revolver, MK II Revolver bullet  
**Dated:** Unknown (pre 1963 – bullets produced after this time evidence only x1 cannelure)  
**Manufacturer:** Unknown  
**Country of Origin:** United Kingdom

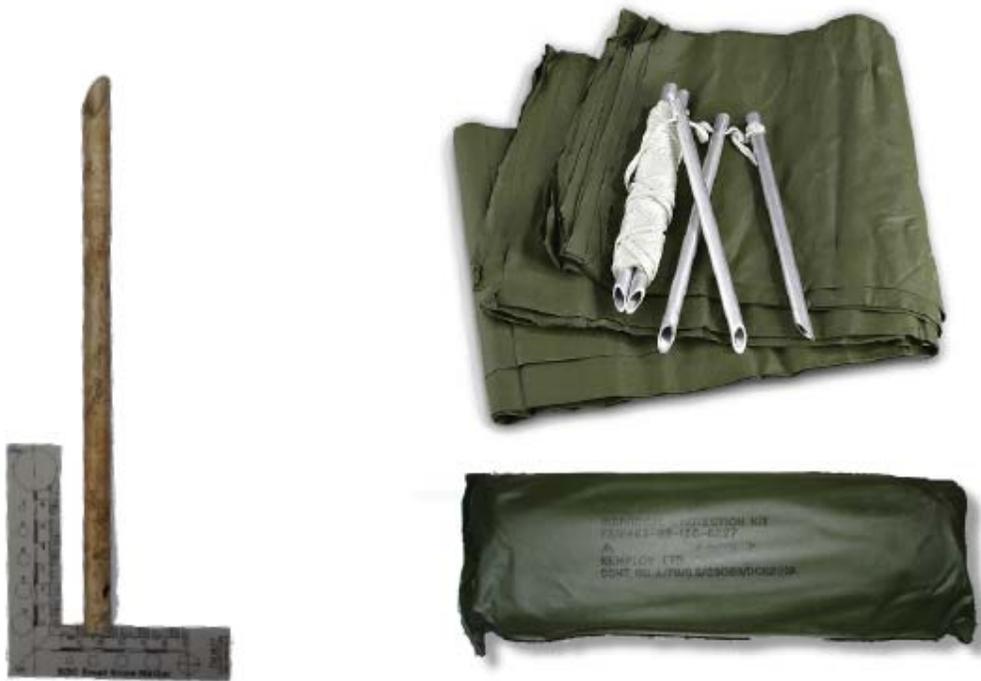
**Type:** Aluminium peg from an Individual Protection Kit

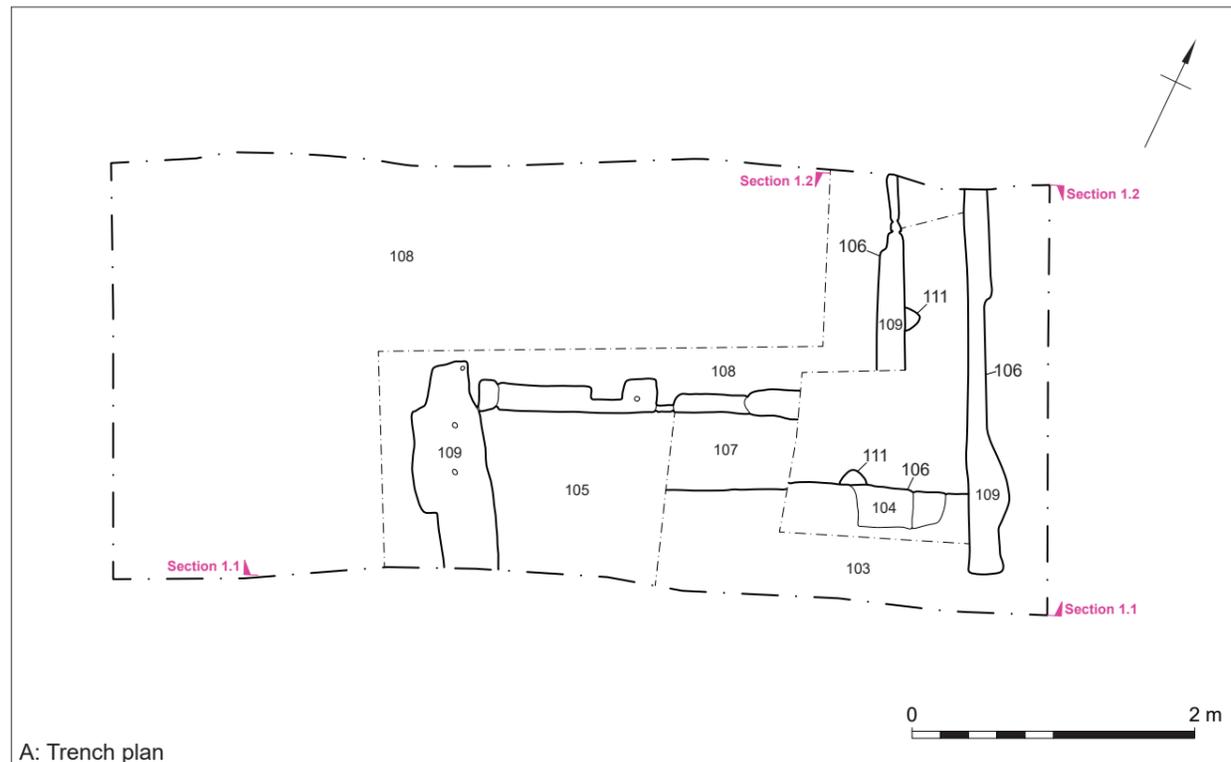
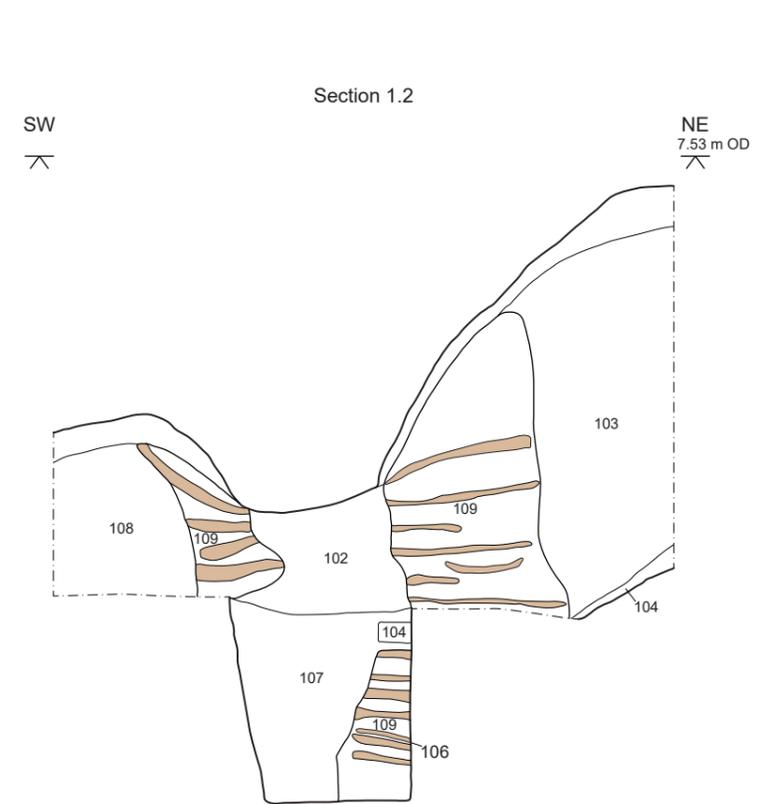
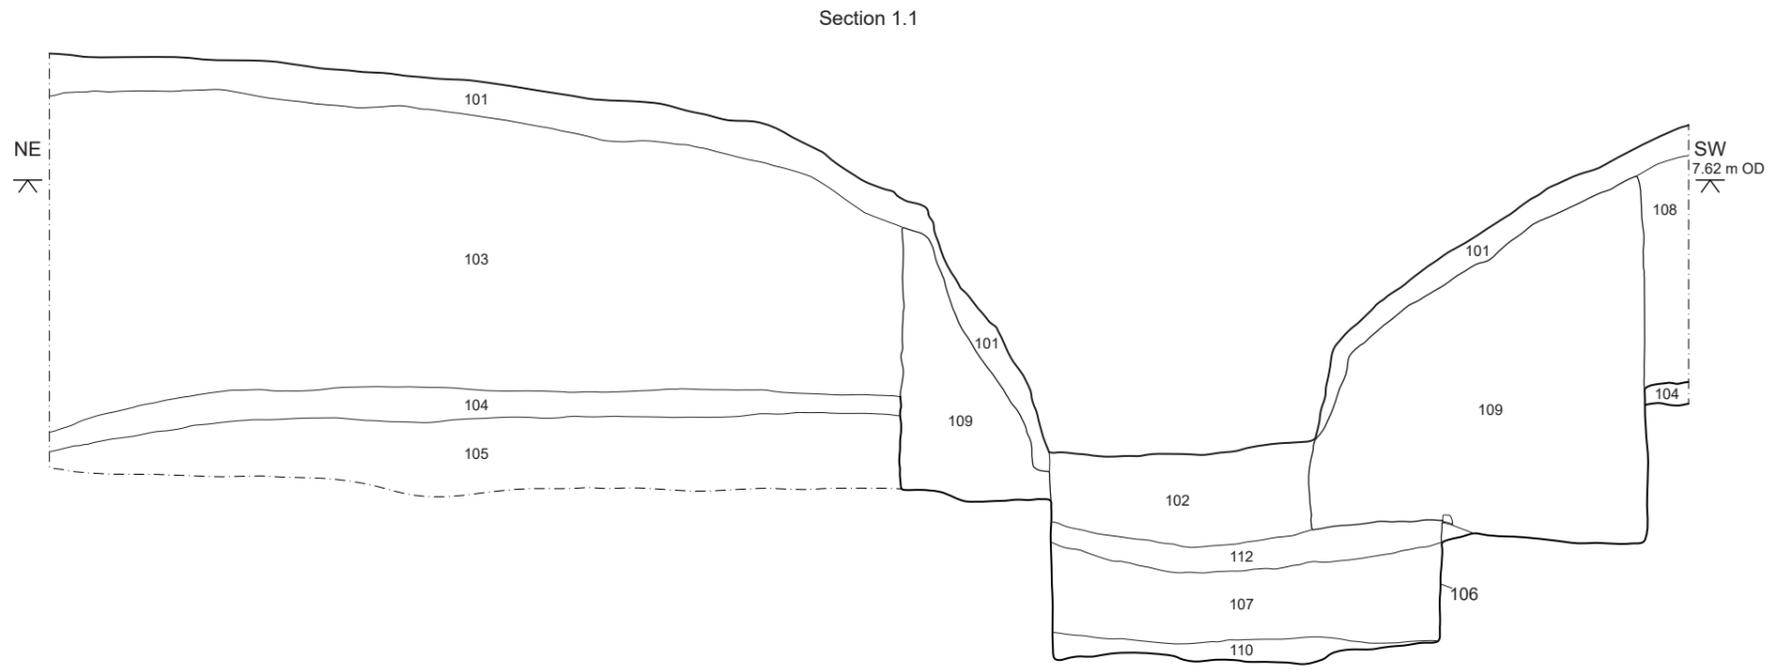
A: Trench plan

B: Sections

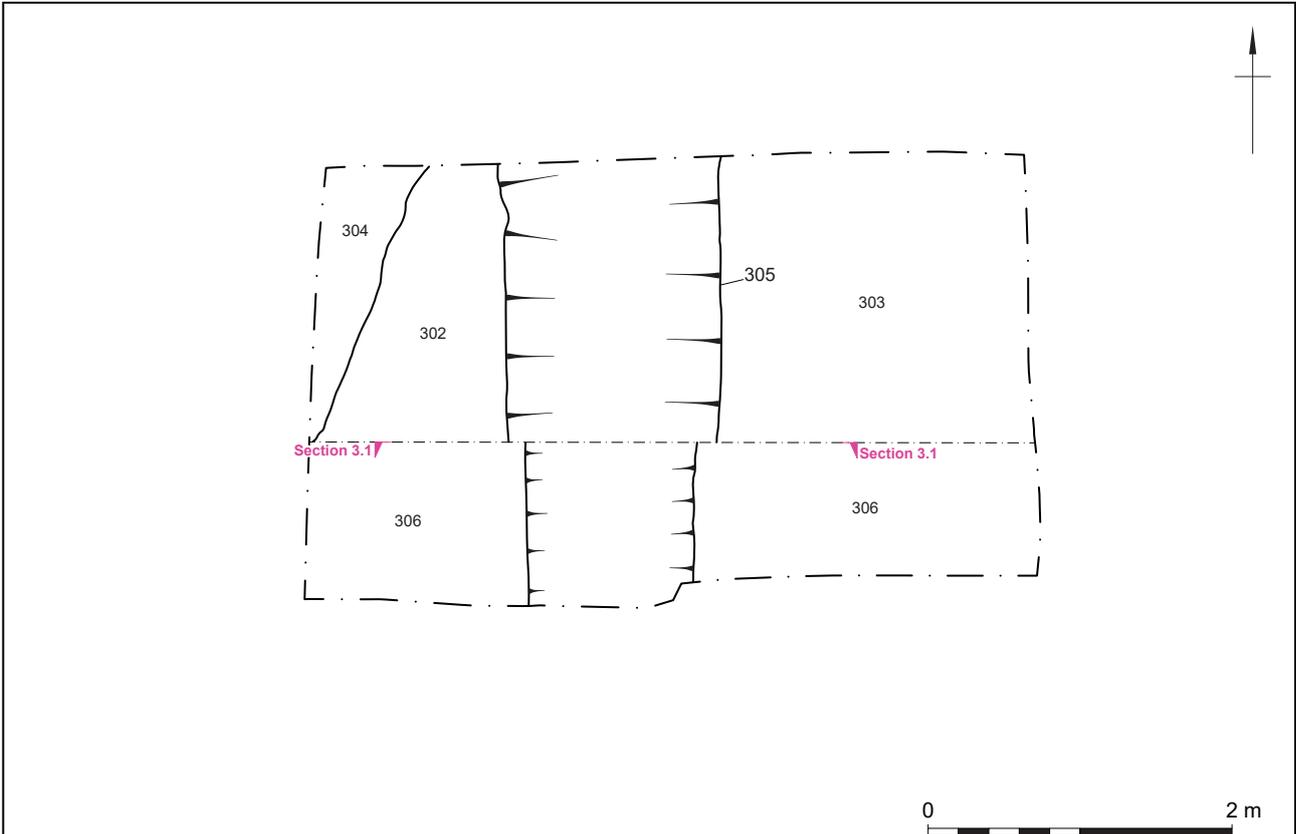
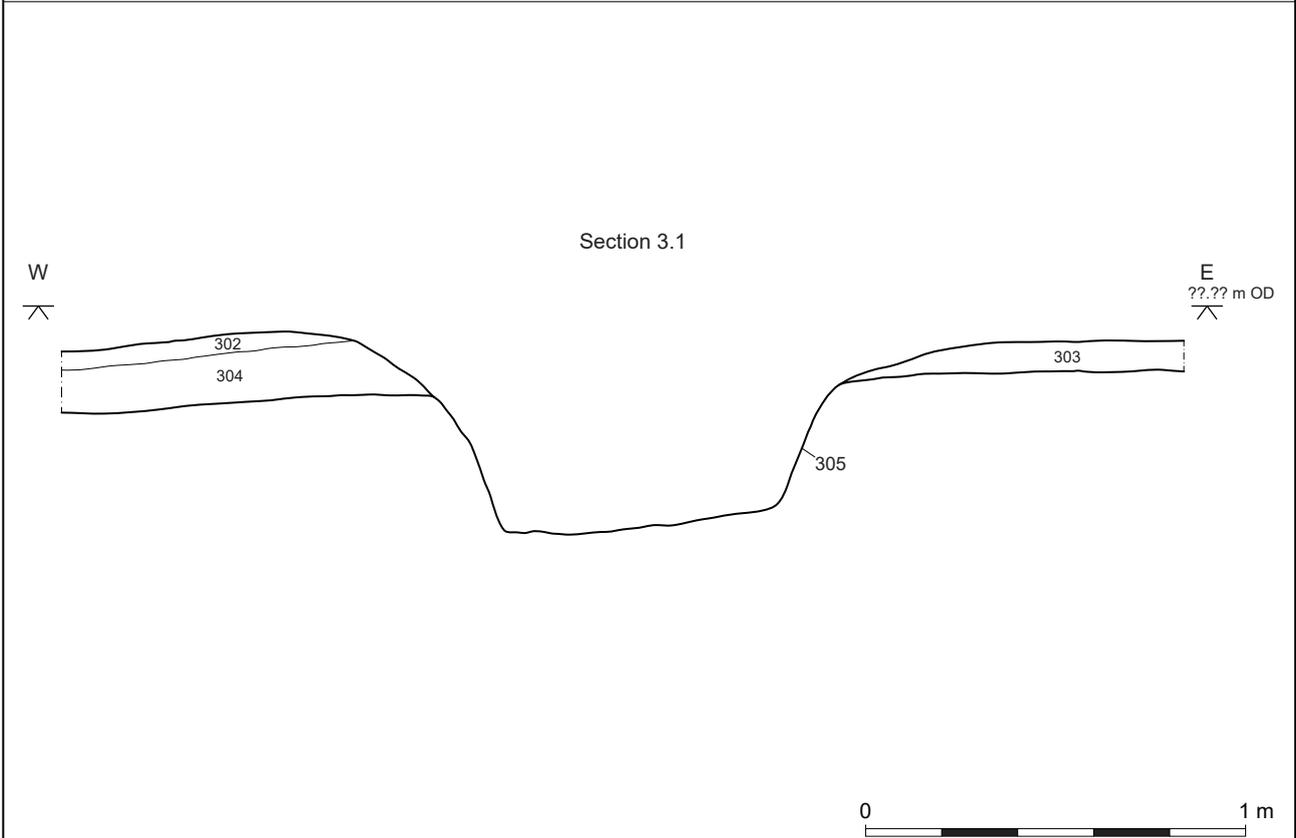
Figure 4

- 4.3.16 Trench three measured 5 m x 3 m and targeted a shallow N-S running crenelated zigzag trench (Figure 4). On removing the turf and topsoil (301) a patch of orangish yellow sand [302] was found to the west of the trench cut [305], which was interpreted as the upcast redeposited material removed when the trench was initially dug. Faint patches of similar deposits were also present on the east side of [305], but not in the quantities of [302]. On both sides of the trench cut [305] was a compacted surface on dark brown soil- [303] to the east of the cut and [304] to the west of the cut, which was interpreted as the buried former land surface, which had then been covered by the upcast material. The trench cut [305] had dug through this and down 0.35 m into the natural sand [306] below. The fully excavated trench is shown in Plate 13. The base of the trench was wide enough for one person to walk or crawl along it (approx. 0.3m wide at the base, widening to 0.6m at the top break of slope) but would never have given protection to someone not lying down in it, even with a greater height of upcast material than remained in [302]. One suggestion for this trench is that it was a practice "bomb trench", which soldiers would drop down into for protection after throwing a grenade or similar munitions. The presence of multiple small scoops roughly 5-10 m to the west close to the back of the frontline trench may be the intended targets for this, forming a small grenade range which could be used with dummy grenades or live ones.

A: Trench plan

B: Section

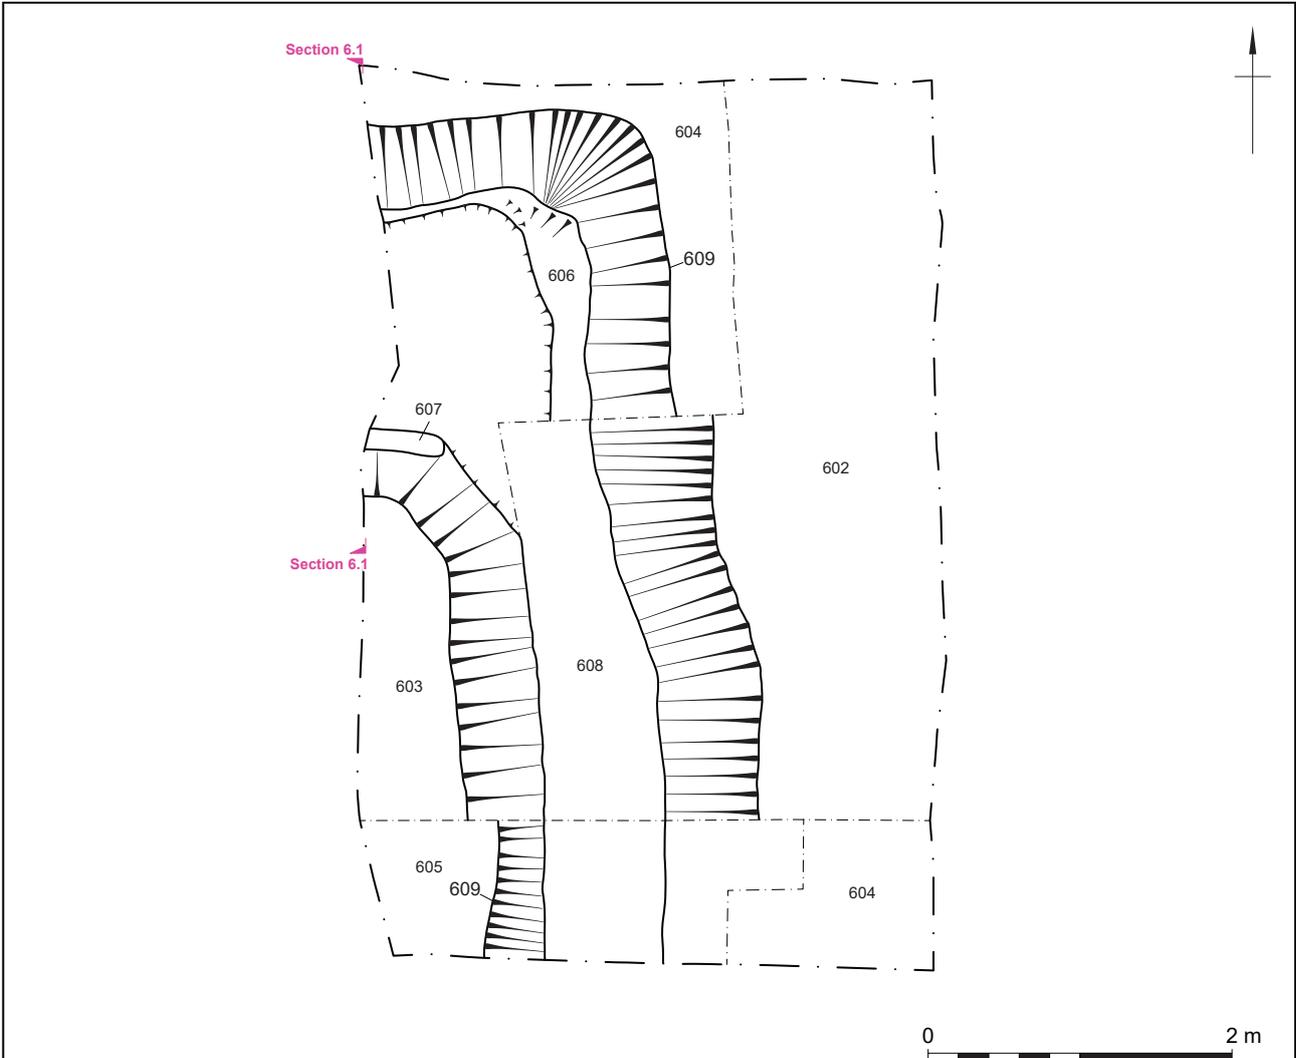
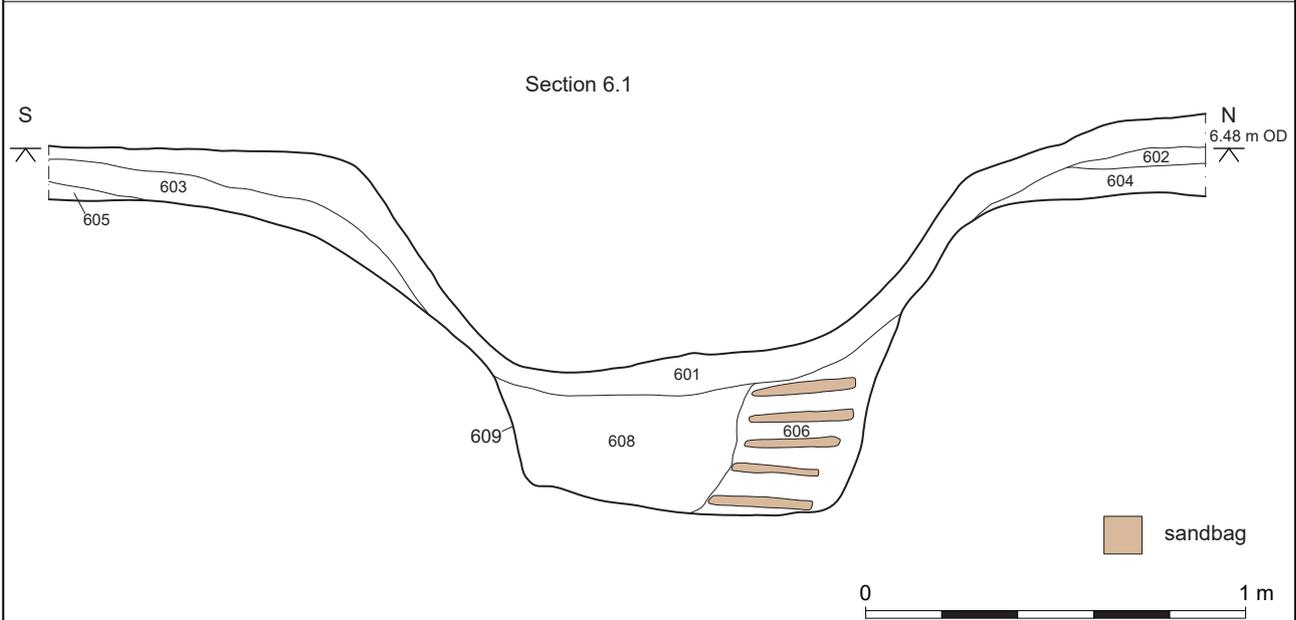
Figure 5

- 4.3.18 Trench six measured 6m x 4m trench and was orientated N-S, targeting the corner of a crenelated zigzag trench which was suspected to be a support trench linked to the frontline by a zigzag communication trench running to the west (full excavation shown in Figure 5, Plate 14). The removal of the turf and topsoil [601] was hampered by the presence of a highly knotted woody root system which covered the north and east part of the trench and by the presence of a small shrub on the western side of the trench cut. Both of these had clearly damaged areas of the underlying stratigraphy. Below the topsoil, turf and roots it was clear that there had been a redeposit of yellowish orange natural material on both sides of the trench cut [609] when the trench system was excavated originally, similar but on a larger scale to that in trench three. The deposit on the northern and eastern side of the trench cut [609] was allocated [602] while the deposit on the southern and western side was allocated [603]. These deposits were approximately 0.15 m thick and overlay the old land

A: Trench plan

B: Section

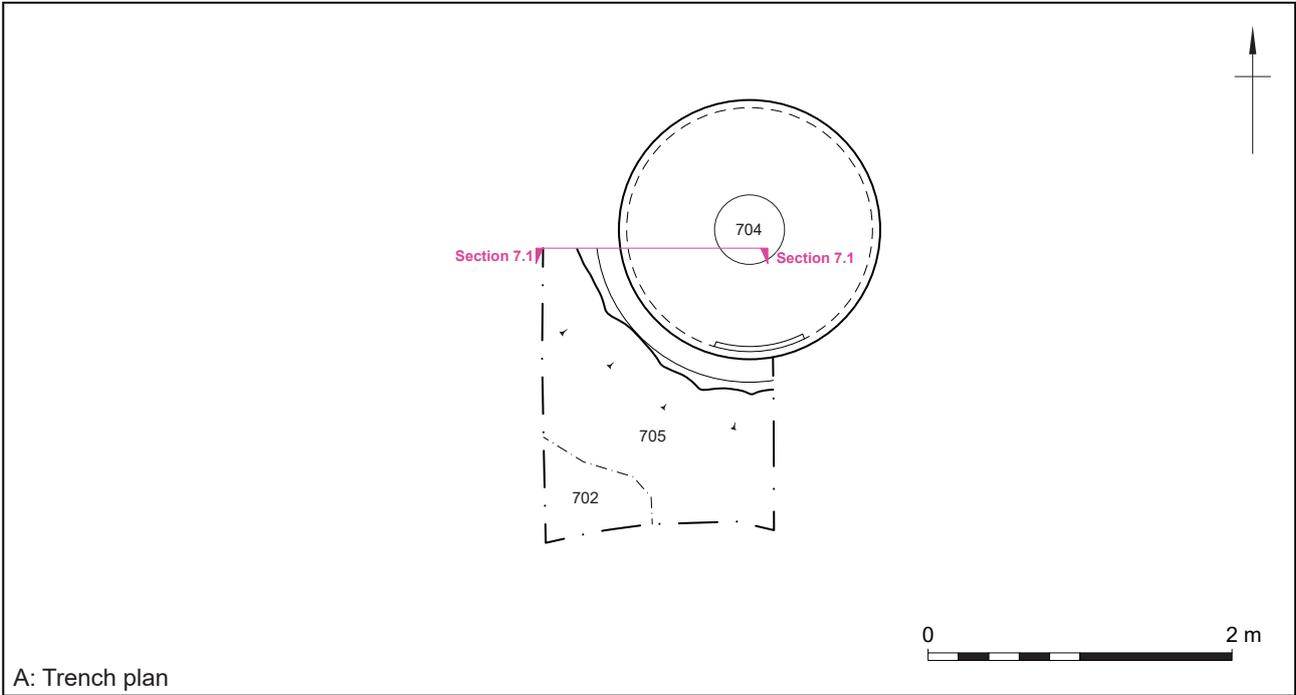
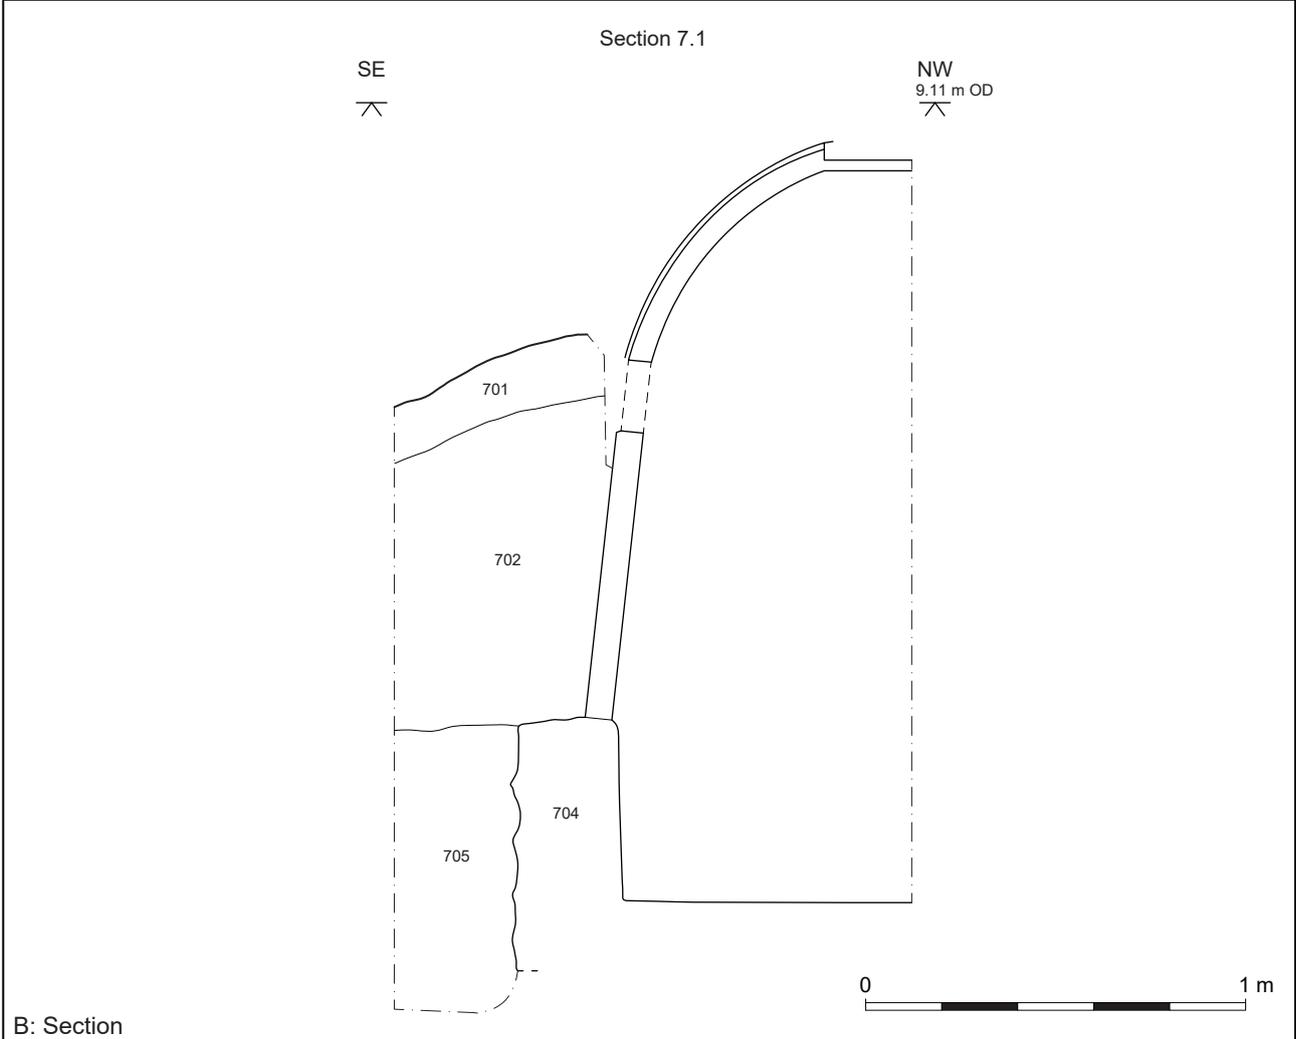
Figure 6

- 4.3.21 Trench seven measured 2 m x 2 m and targeted the south-west quadrant of the iron/steel dome structure identified prior to excavation as an Allan-Williams turret and associated mound (Figure 6). This trench was intended to assess the overall condition of the structure and to discover how it was constructed, as well as to attempt to find some dating evidence for the structure. Below the turf and topsoil [701] was a homogeneous layer of blown sand accretion [702] which had clearly built up against the upper metal of the structure since its construction. A shallow trench-like gully running to the entrance hatch in the southern side from the southwest had no obvious cut through this sand and may well have been a result of repeated movement wearing down or compacting the material, rather than a deliberate cut.

A: Trench plan

B: Section

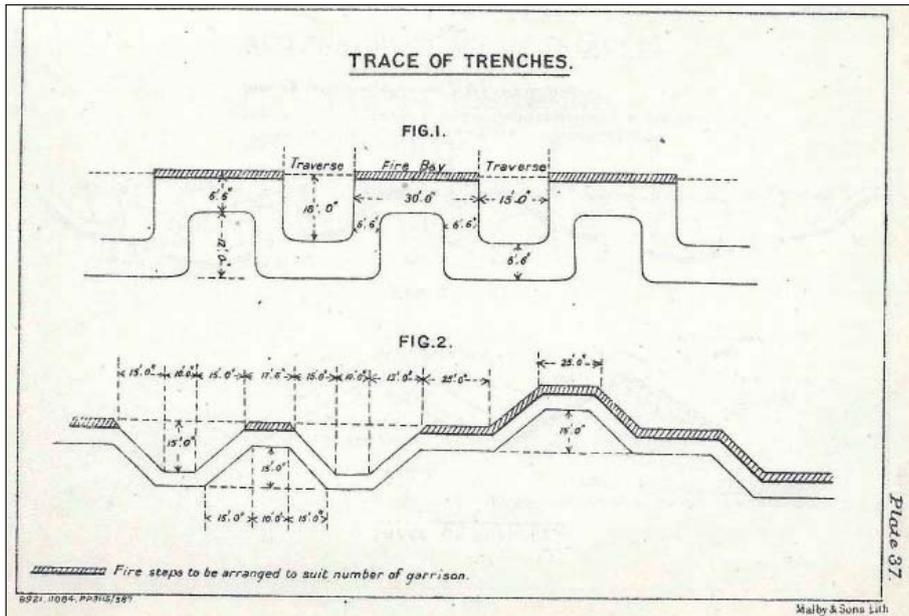
Plate 1: Schematic of Frontline trench in plan. From 1921 British Army Field Manual, Plate 37

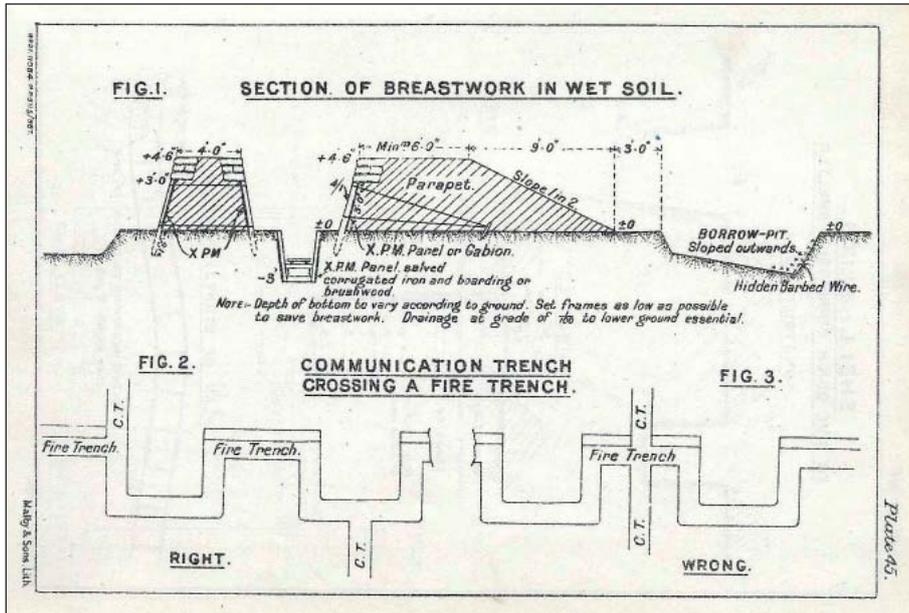
Plate 2: Cross Section through trench with breastwork (for use in wet soil). From 1921 British Army Field Manual, Plate 45

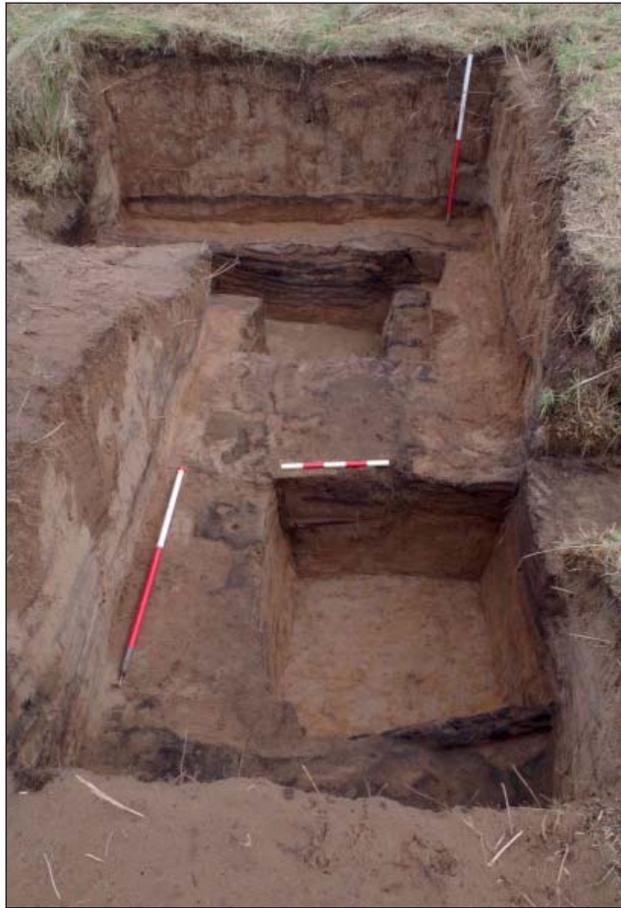
- 4.3.5 A piece of preserved horizontal timber running N-S along the inner side of the western edge of the trench was identified as potentially a remnant of the fire step, located as it was abutting the parapet next to the traverse. Additional stakeholes, part of the sandbag, timber and wire revetment were found along the inner sides of the sandbag piles including a postpipe [111].

Plate 3: Full excavation photo of trench one, looking east, with sandbag revetments showing along edge of trench. Wooden fire step fragment in bottom left corner.

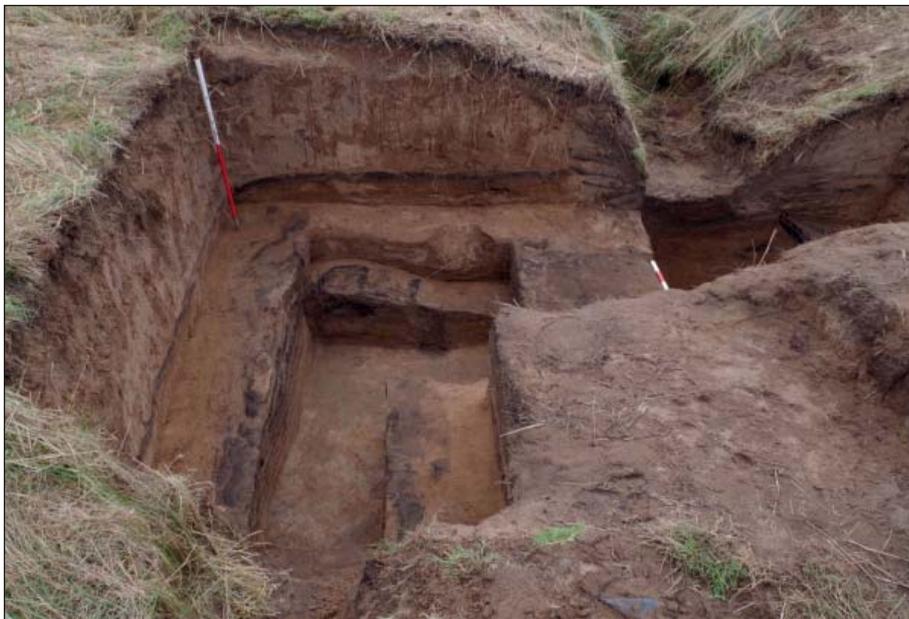
Plate 4: Full excavation photograph of trench one, looking south, showing sandbag revetment, old ground surface and build-up of material to form paradose behind sandbags
