# Barry Buddon First World War Training Trenches

Archaeological Evaluation: Data Structure Report

Ref: 117440.01  
October 2017

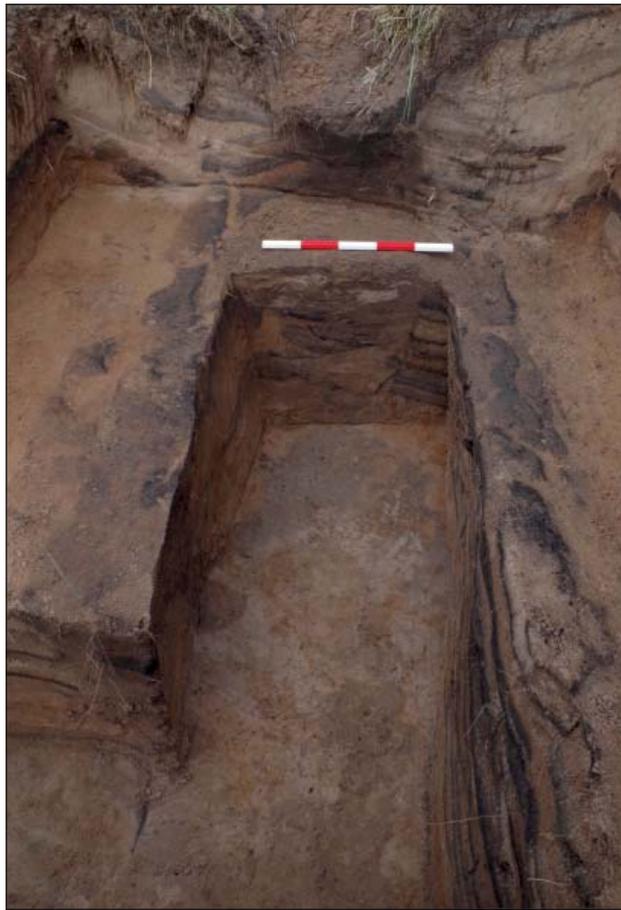
Plate 5: Full excavation photograph looking north of trench one showing sandbag revetments within trench cut [106] and infilling layers of trench

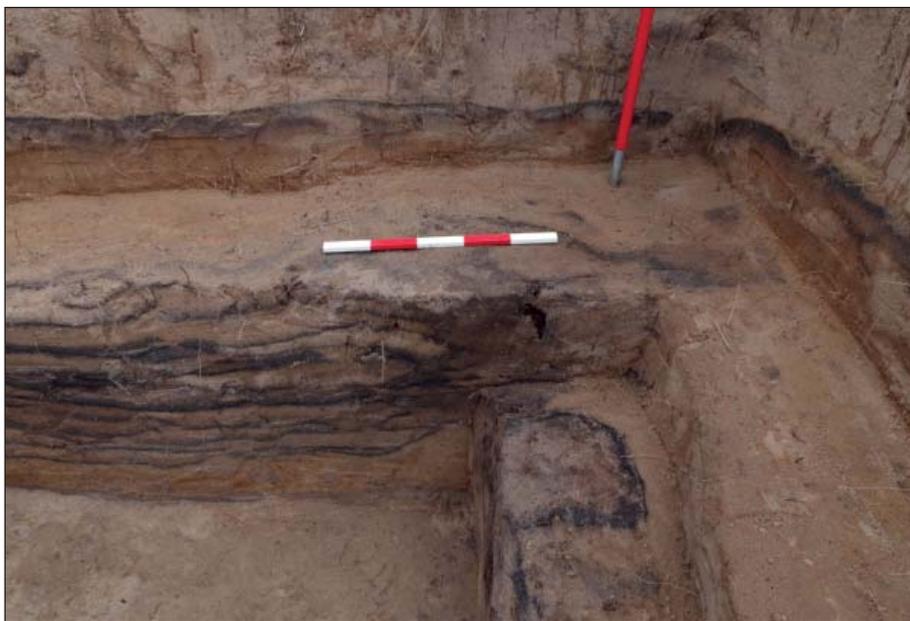
Plate 6: Close up details of sandbag revetment on eastern side of trench with old land surface and building up of paradose material. Looking east.

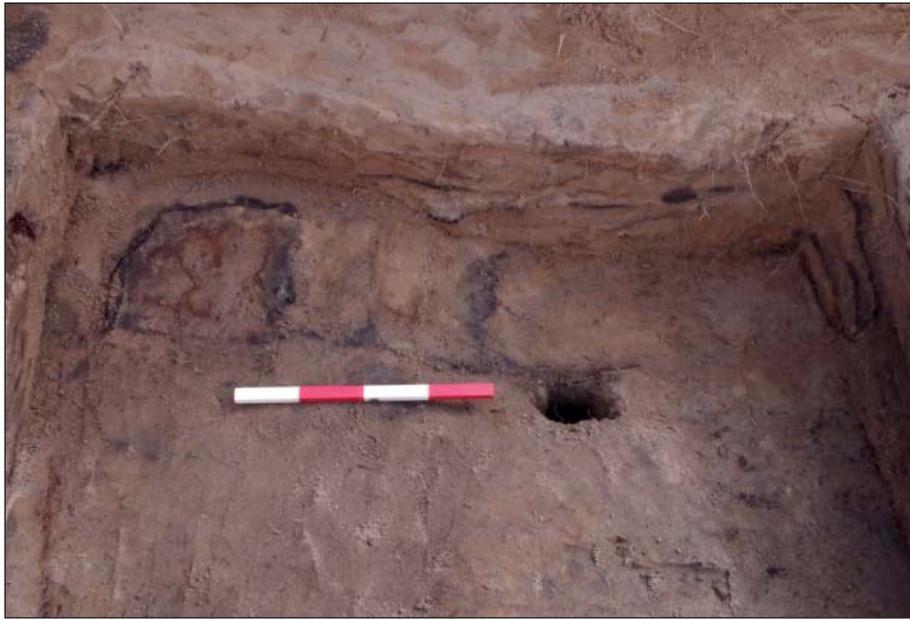
- 4.3.5 A piece of preserved horizontal timber running N-S along the inner side of the western edge of the trench was identified as potentially a remnant of the fire step, located as it was abutting the parapet next to the traverse. Additional stakeholes, part of the sandbag, timber and wire revetment were found along the inner sides of the sandbag piles including a postpipe [111].

Plate 7: Close up looking south of sandbag material within trench one and postpipe [111]

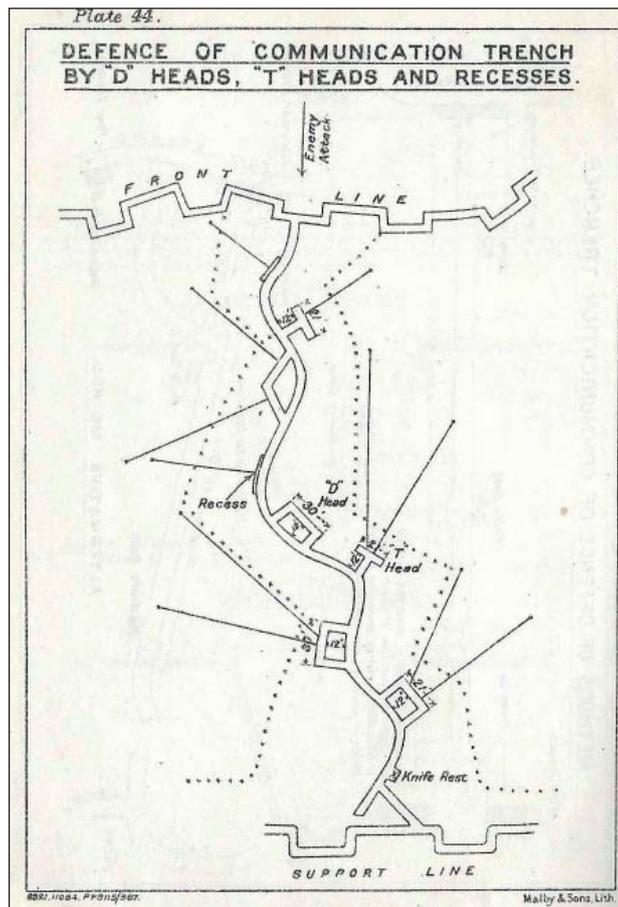
Plate 8: Defence of communication trench by "D" Heads, "T" Heads and recessed. From 1921 British Army Field Manual, Plate 44

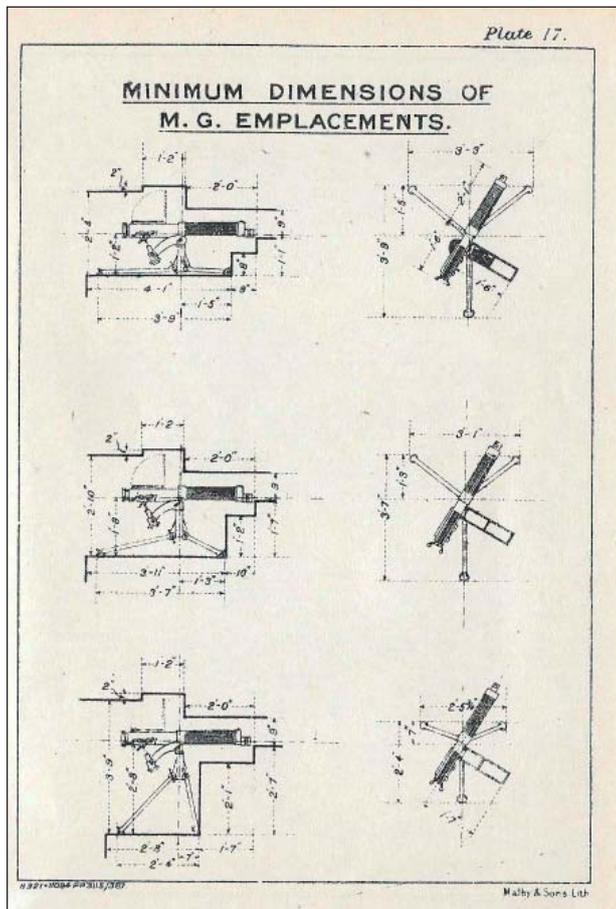
Plate 9: Minimum dimensions of M.G. emplacements.  
From 1921 British Army Field Manual, Plate 17

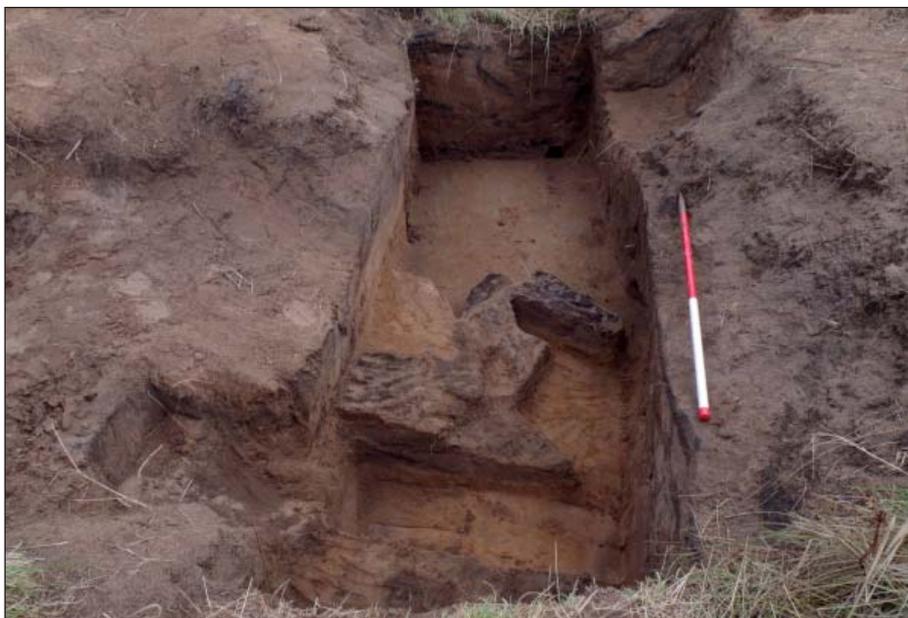
Plate 10: Full excavation photograph of trench two, Machine Gun Pit showing base of cut into natural and sandbags on top of trample layer [208]. Looking south

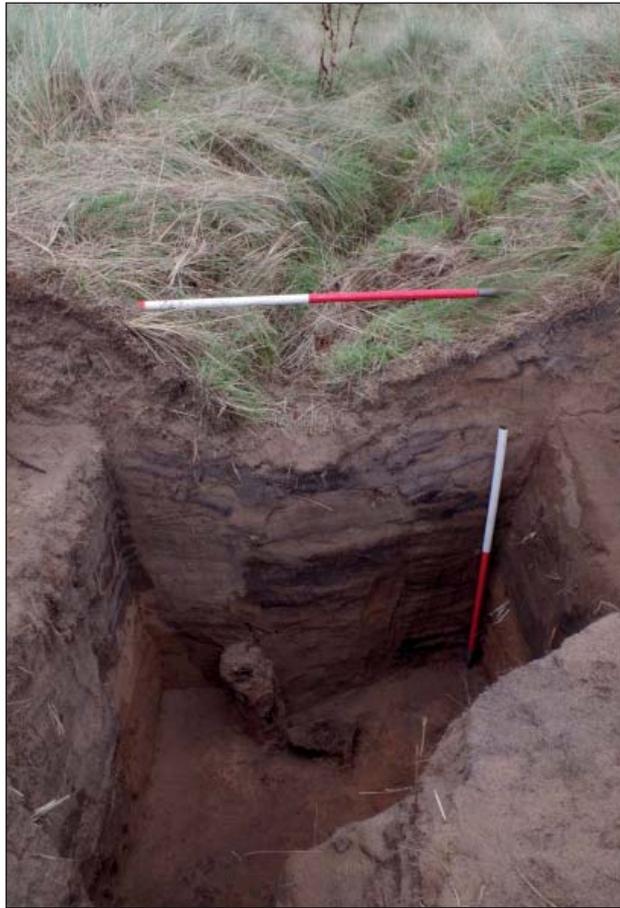
Plate 11: Full excavation photo of trench two access trench looking east showing collapsing sandbag banding, cut into natural for trench and trench infilling

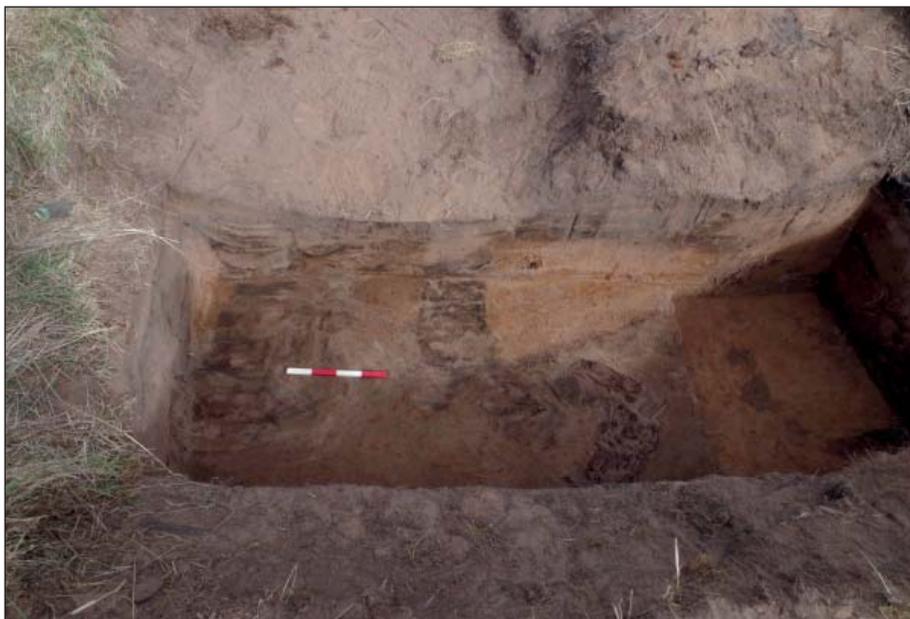
Plate 12: Mid-ex of trench two Machine Gun Pit showing continuation of sandbag revetments along edge of access trench entering MGP. Looking southeast

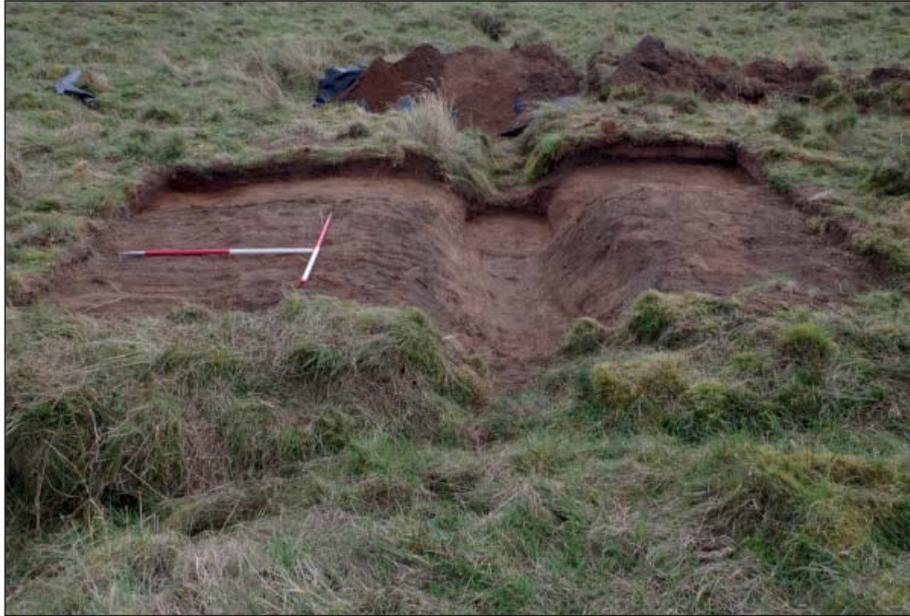
- 4.3.16 Trench three measured 5 m x 3 m and targeted a shallow N-S running crenelated zigzag trench (Figure 4). On removing the turf and topsoil (301) a patch of orangish yellow sand [302] was found to the west of the trench cut [305], which was interpreted as the upcast redeposited material removed when the trench was initially dug. Faint patches of similar deposits were also present on the east side of [305], but not in the quantities of [302]. On both sides of the trench cut [305] was a compacted surface on dark brown soil- [303] to the east of the cut and [304] to the west of the cut, which was interpreted as the buried former land surface, which had then been covered by the upcast material. The trench cut [305] had dug through this and down 0.35 m into the natural sand [306] below. The fully excavated trench is shown in Plate 13. The base of the trench was wide enough for one person to walk or crawl along it (approx. 0.3m wide at the base, widening to 0.6m at the top break of slope) but would never have given protection to someone not lying down in it, even with a greater height of upcast material than remained in [302]. One suggestion for this trench is that it was a practice "bomb trench", which soldiers would drop down into for protection after throwing a grenade or similar munitions. The presence of multiple small scoops roughly 5-10 m to the west close to the back of the frontline trench may be the intended targets for this, forming a small grenade range which could be used with dummy grenades or live ones.

Plate 13: Full excavation photograph of trench three. Looking south

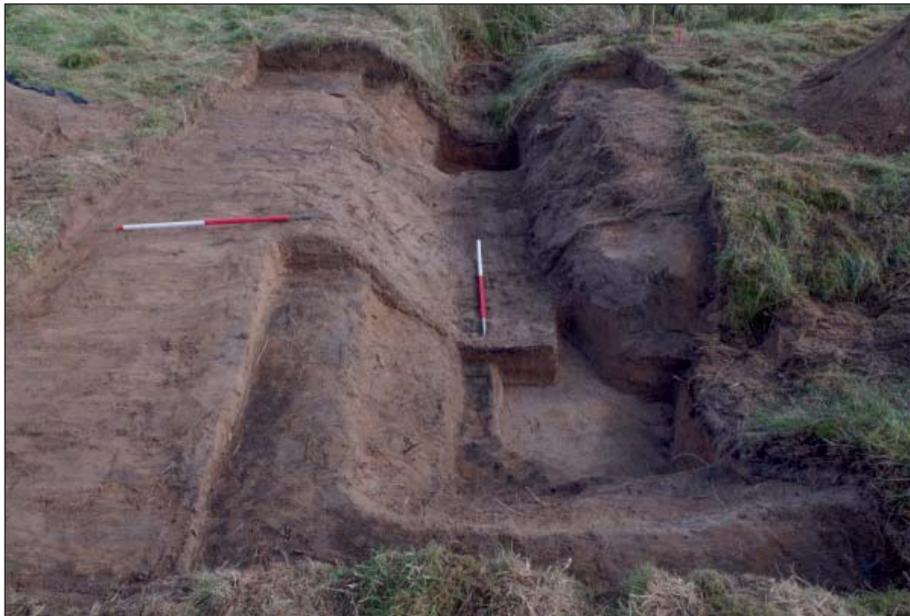
Plate 14: Mid excavation photo of trench six showing sandbag revetment in north eastern corner of trench base, redeposited material on parapet and old land surface. Looking south

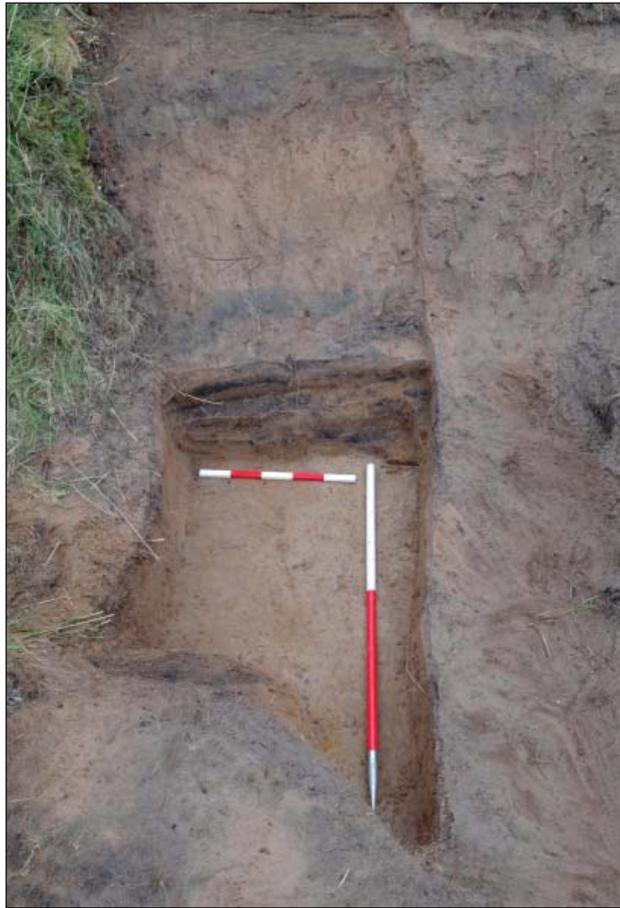
Plate 15: Mid excavation photograph of northern slot in trench six showing sandbag revetments along northern edge of WWI trench. Looking north

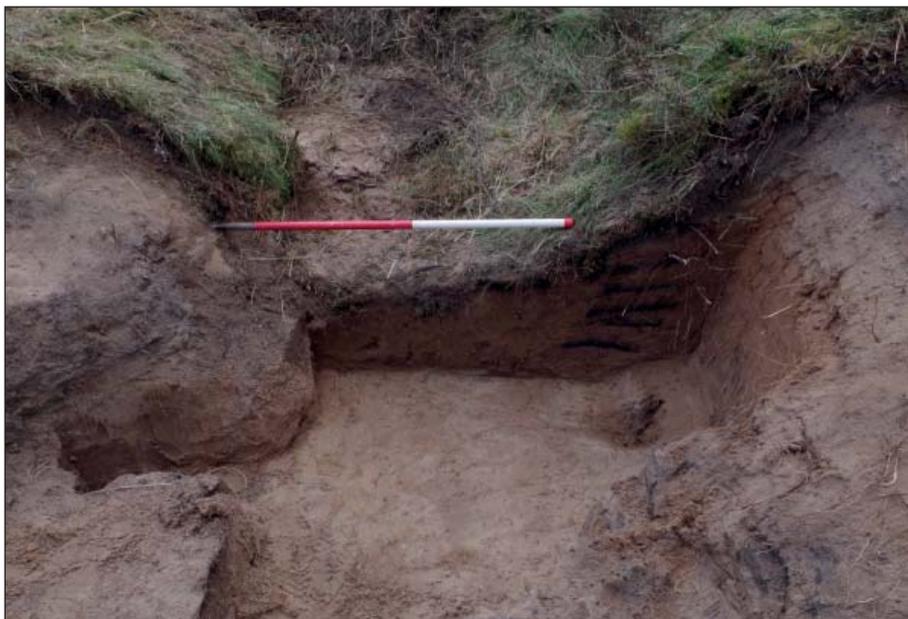
- 4.3.19 The trench cut [609] was filled with a loose to firm yellowish-brown sand [608] which appeared to be a general accretion layer of sands and soils formed by a combination of windblown sand and the slumping/collapsing in of the trench sides, as seen in trenches one and two. This filled the trench cut to a maximum depth of approximately 0.3 m and was fully excavated in two slots, one at the southern edge of the trench (1 m wide) and one over the corner of the trench system at the northern end of the trench (2 m wide). Within the northern slot a pile of sandbags [606] (one sandbag thick and roughly eight sandbags high in places) running along the northern and east edge of the WWI trench and around the corner of the trench system was observed. These were stacked along the edge in a similar manner to those in the Frontline trench in trench one and in the access trench to the MGP in trench two to form a revetment to hold back the soft sediments the trench system had been cut into (Plate 15 and Plate 16). Signs of a similar revetment of sandbags [607] were present on the inner southern and east edge, although this was much less certain, and may have been a sandbag that had fallen from the main stack, as seen in the base of the MGP in trench two. The stack of sandbags had clearly slumped down into the trench over time, due to the pressure of sediments behind and above.

Plate 16: Full excavation photograph showing western section through WWI trench with slumped sandbag revetment along northern edge. Looking west

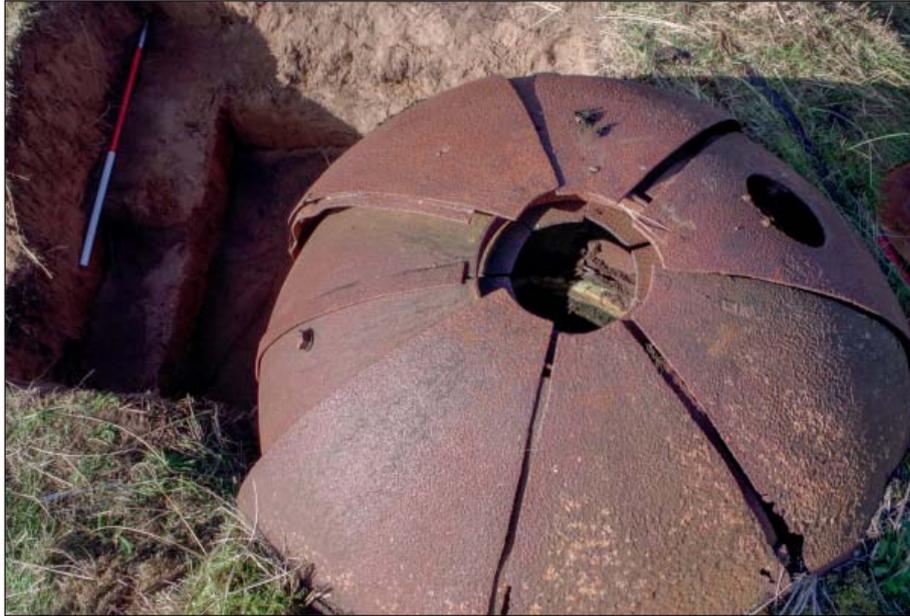
The hatchway in the southern most sheet was a rectangle with rounded corners measuring 0.75 m high by 0.5 m wide, which was closed by an internal hatch 0.8 m high by 0.55 m wide, shutting on double action hinges and a cantilever arm. Two locking pins, one top and one bottom, enabled it to be locked from the inside. Both the hatch and the circular plate covering the top of the turret had been detached in the past and were found within the structure. The whole steel upperworks were bolted onto the concrete base. Internally the structure was 2.1m high from the internal concrete base to the internal centre point of the dome, while the whole structure stood 2.3 m from the internal concrete base to the top of the exterior of the cupola.

Plate 17: Top view of the steel dome structure, showing overlapping steel plates, double skin and other fittings. Looking west

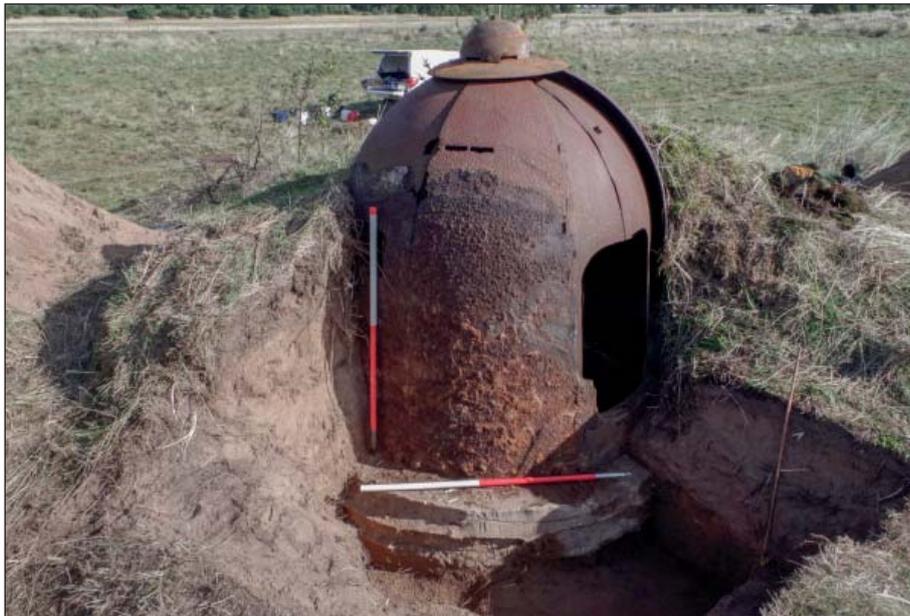
- 4.3.23 From the internal fill [703] which was a sludgy waterlogged mix of blown sand and organic matter, it was clear that the structure had been used as shelter and for cooking up rations during the post-war period, with both modern and earlier munitions found inside. These consisted of 5.56 mm blanks dating to the 1990s and 2000s, 7.62 mm blanks dating to the 1960s-1980s, two pre-1963 revolver bullets, a light machine gun fired white signal round dated 1974 and a WWI era .455 Smith and Wesson revolver bullet. Four .303 wooden bullet blank cartridge casings were also found which were probably fired from a Bren light machine gun and date to WWII or immediately before. As well as the munitions the structure contained detritus of modern army training (a Hexamine solid fuel stove, plastic bags, aluminium spikes from an individual protection kit). Modern drinks cans and other rubbish was also present inside.

Plate 18: Full excavation photograph of trench seven showing steel dome structure and associated concrete base with blown sand accretion on all sides. Looking north-east

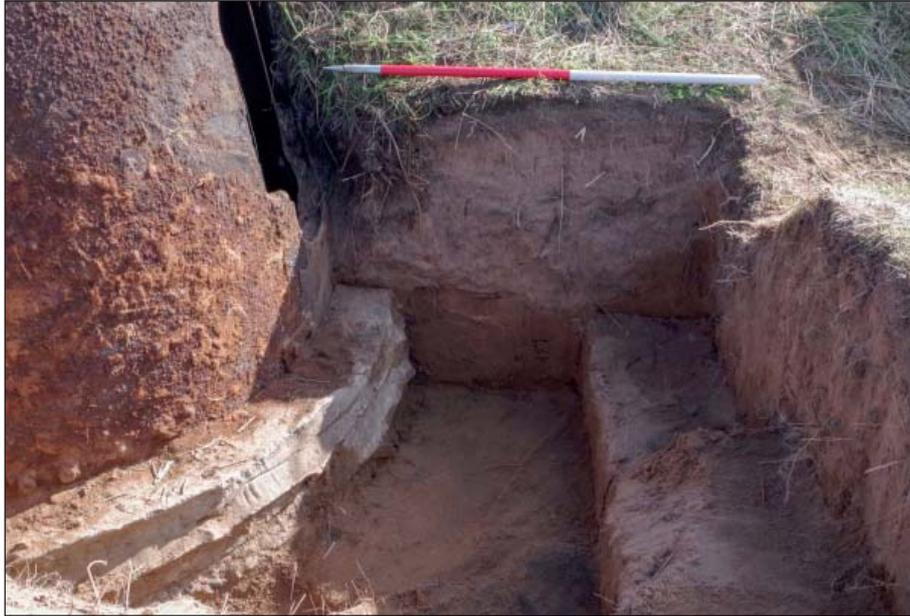
Plate 19: Mid excavation photograph of trench seven, showing concrete base with impressed sandbags used as shuttering
