Digging Band of Brothers: Aldbourne 2019

Site Code: ALD19

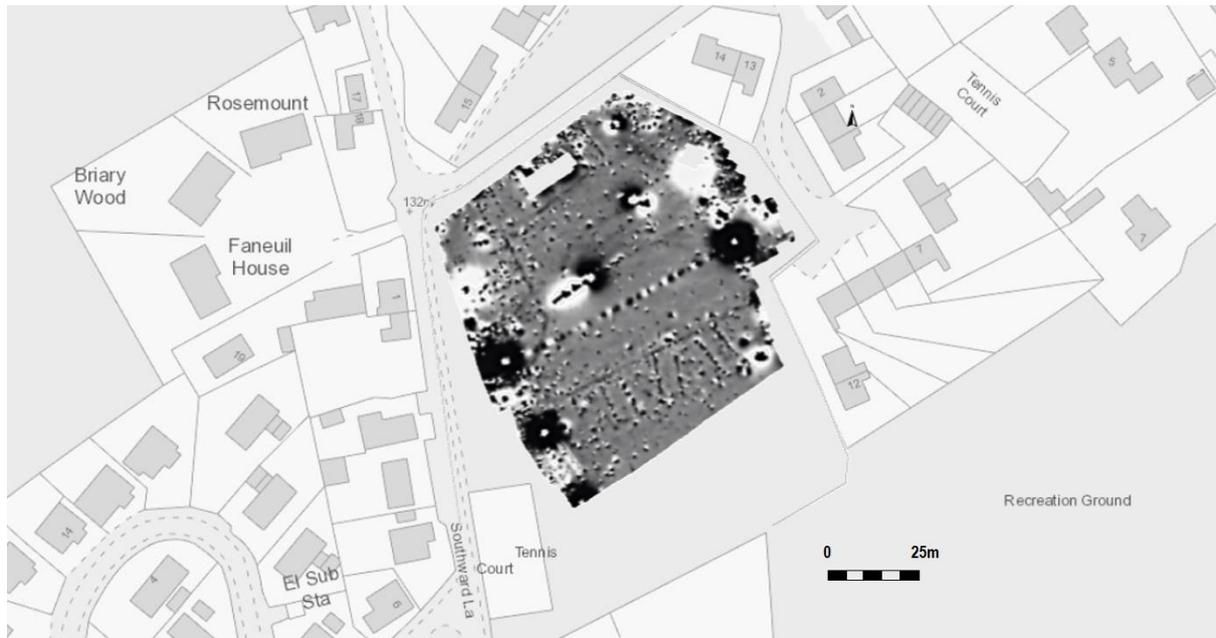
Fig 1: The location of the Easy Company camp site in Aldbourne, with the geophysical survey by Archaeological Surveys overlain

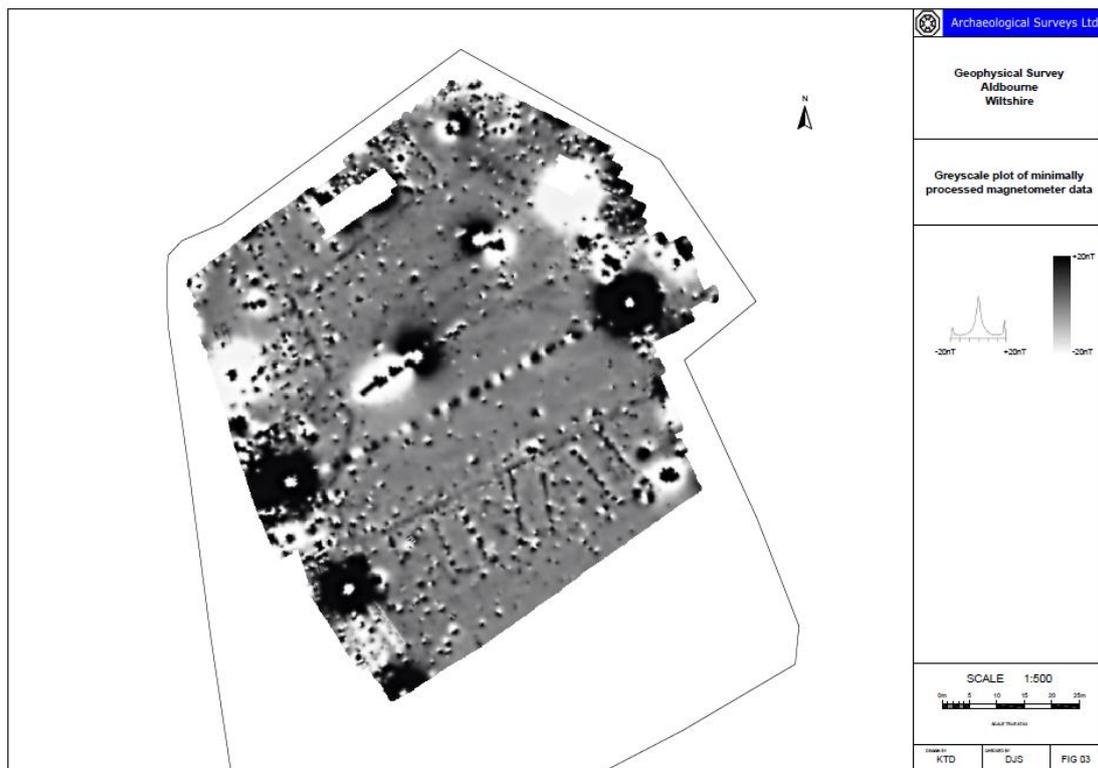
Fig 2: The magnetometry survey of the Easy Company camp site at Aldbourne by David Sabin, Archaeological Surveys Ltd

David Sabin of Archaeological Surveys Limited undertook a geophysical survey of the camp sites of both Ramsbury and Aldbourne in February 2019. The results of the latter are presented here. In spite of the site being level today, and with anecdotal evidence for the area having been not only fairly extensively metal detected but also much truncated following the insertion of floodlights and drains for sports usage, the results were positive. What looked as though they might be footing of the old huts could be seen in the northern half of the football pitch, and there were other suspicious anomalies that might represent the paths running between huts. These corresponded with some of

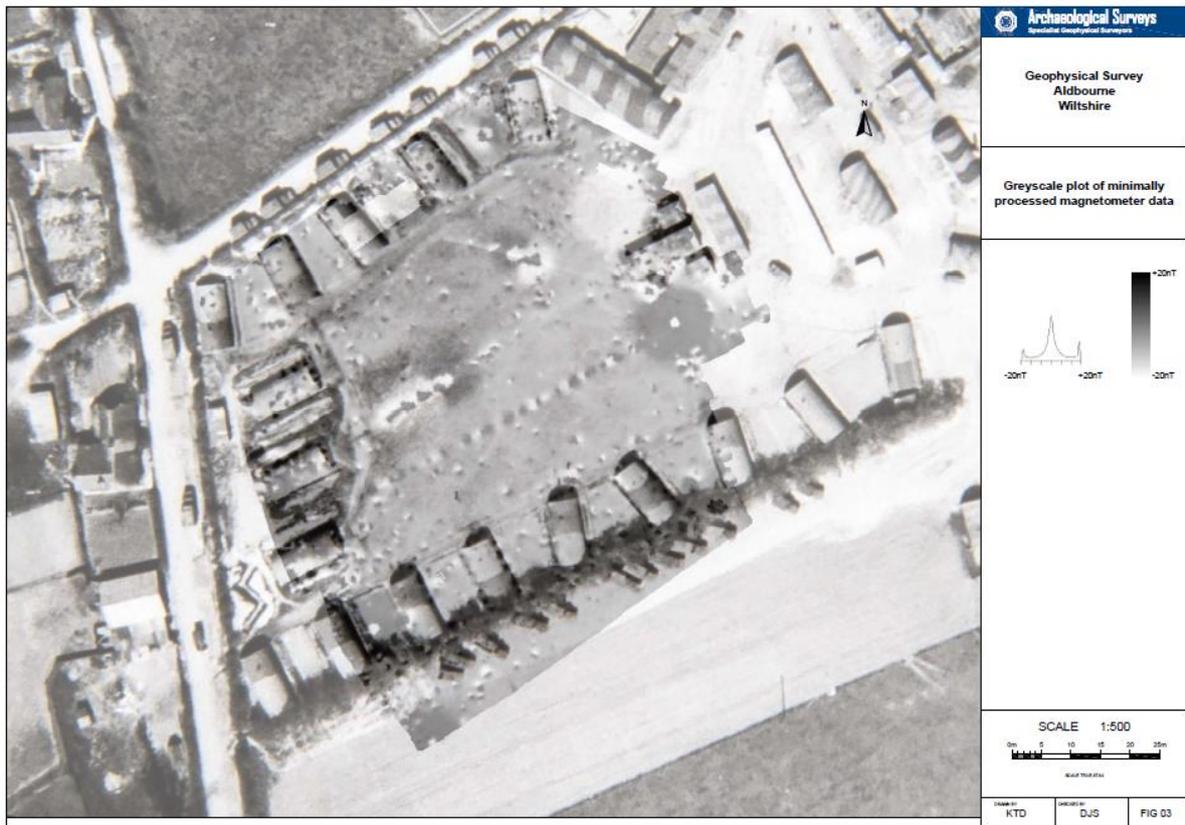
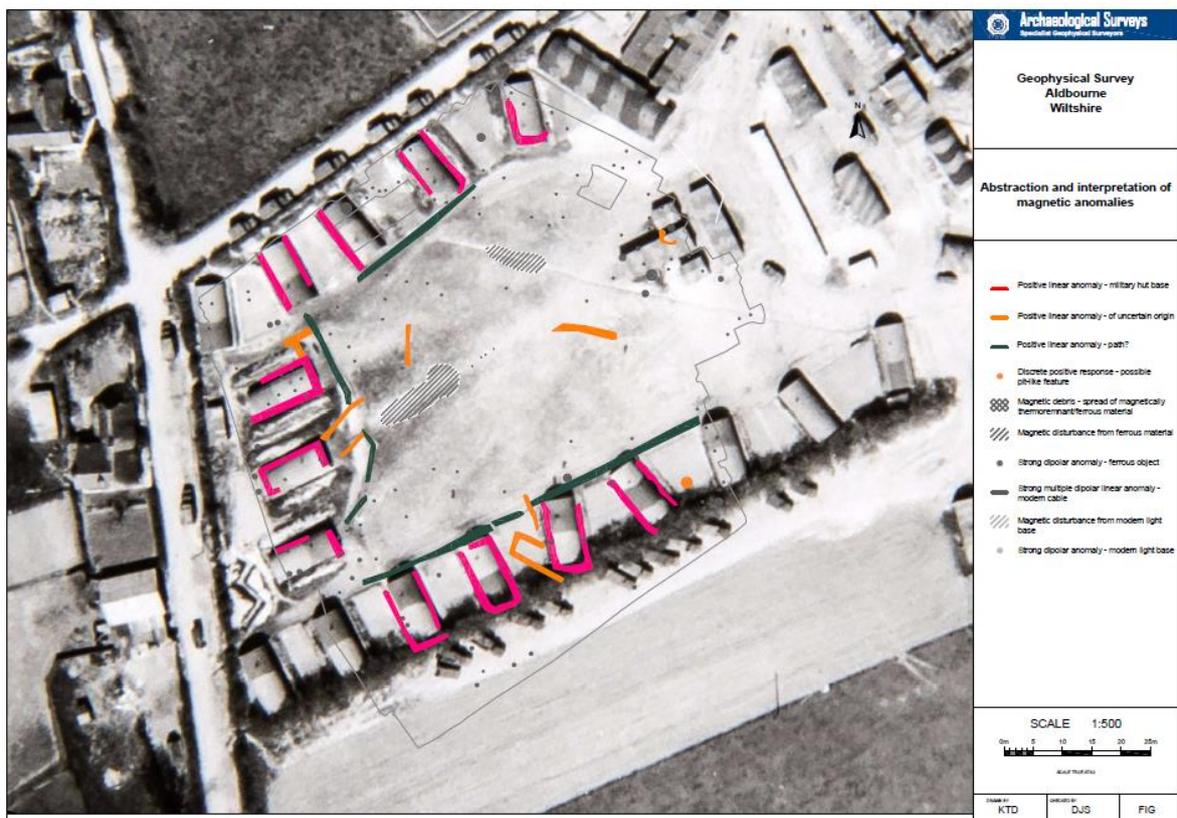
Figs 3 & 4: Aerial photographs of the Easy Company camp site at Aldbourne, with both geophysical survey and interpretations overlain. Note the fine correlation of survey responses to aerial photographic presence of huts indicating potential for surviving deposits.

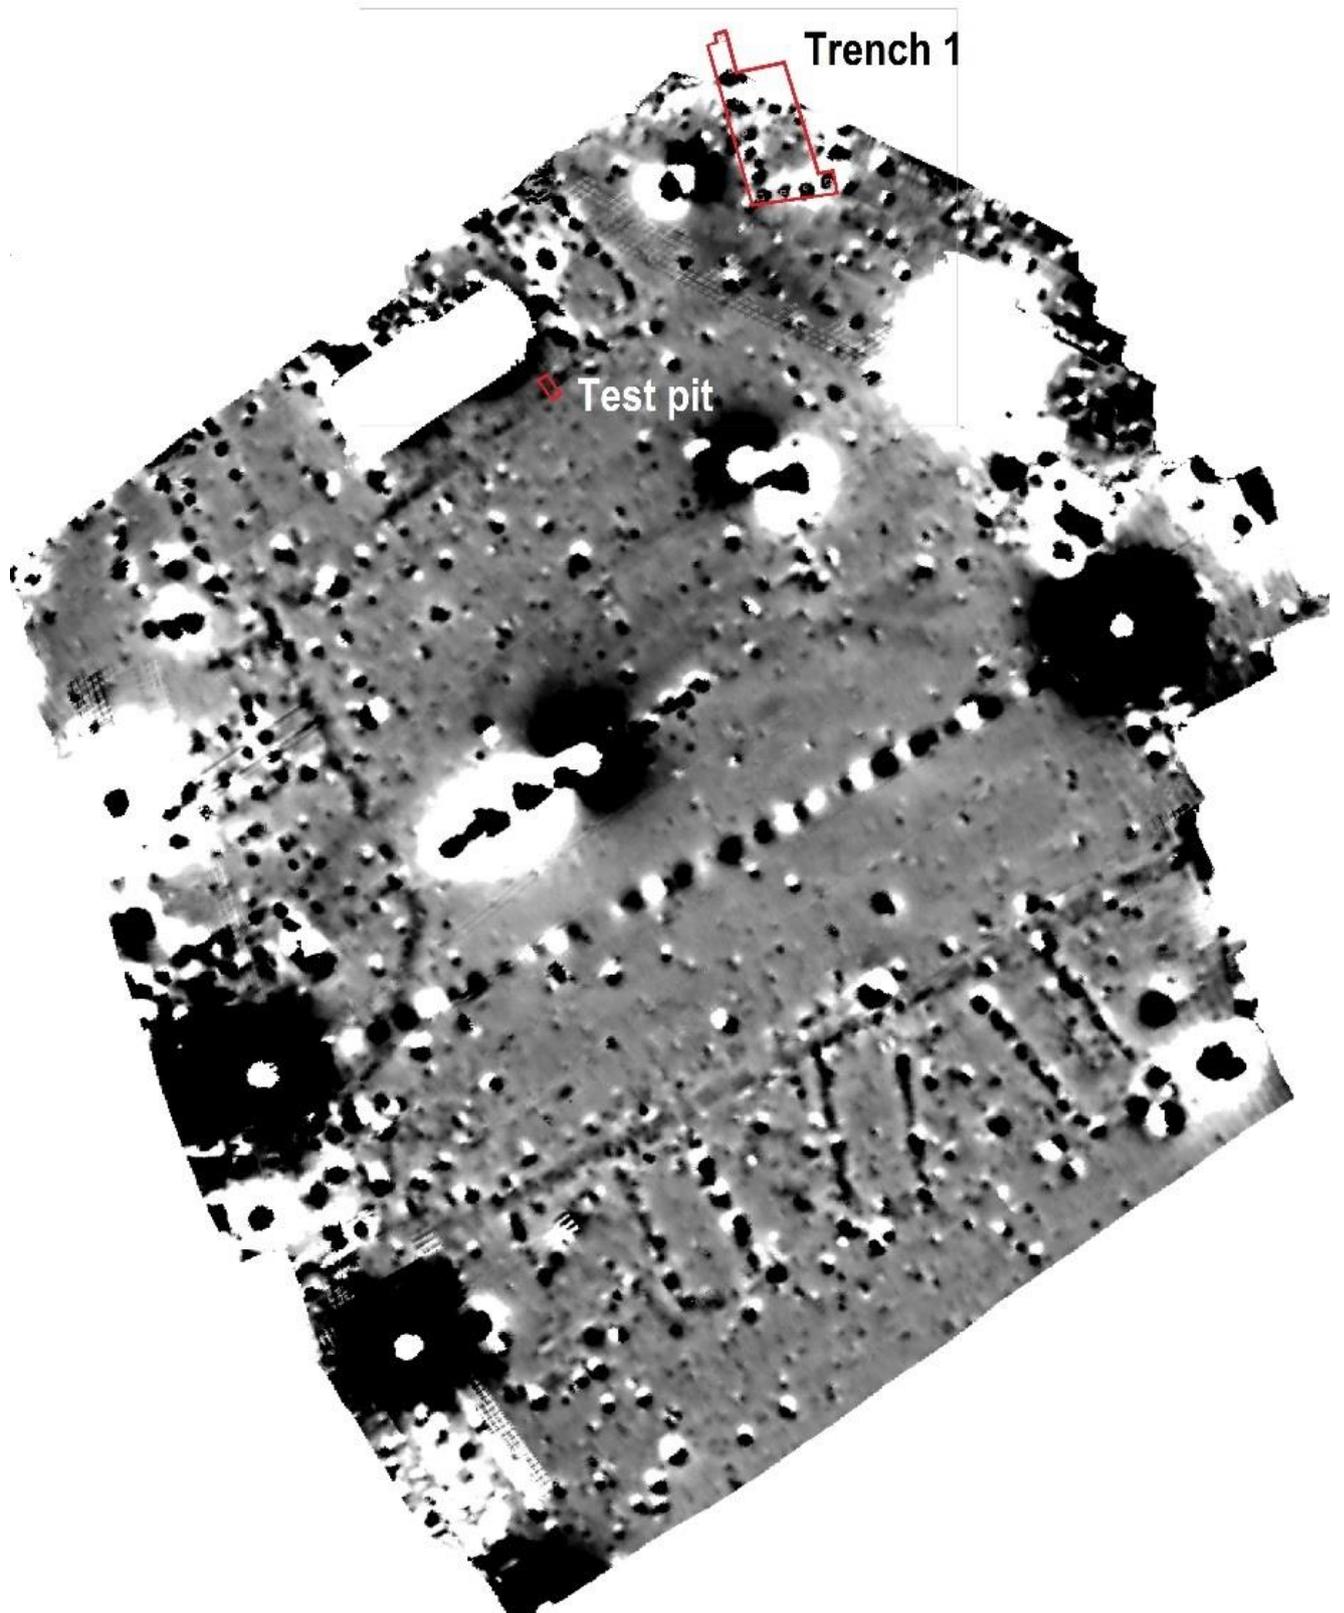
Fig 5: Trench (and test pit) location in relation to the geophysical survey

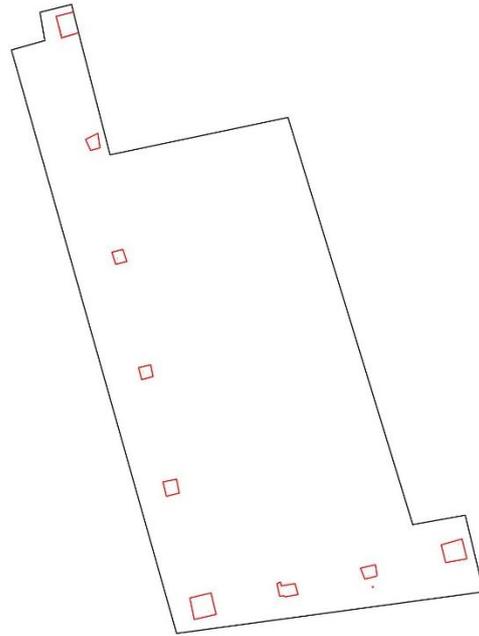
Fig 6: Trench 1 and Test pit at Aldbourne – note the post pads in the main excavation area. These pads are 4.9m (16ft) from corner to corner on the southern face.

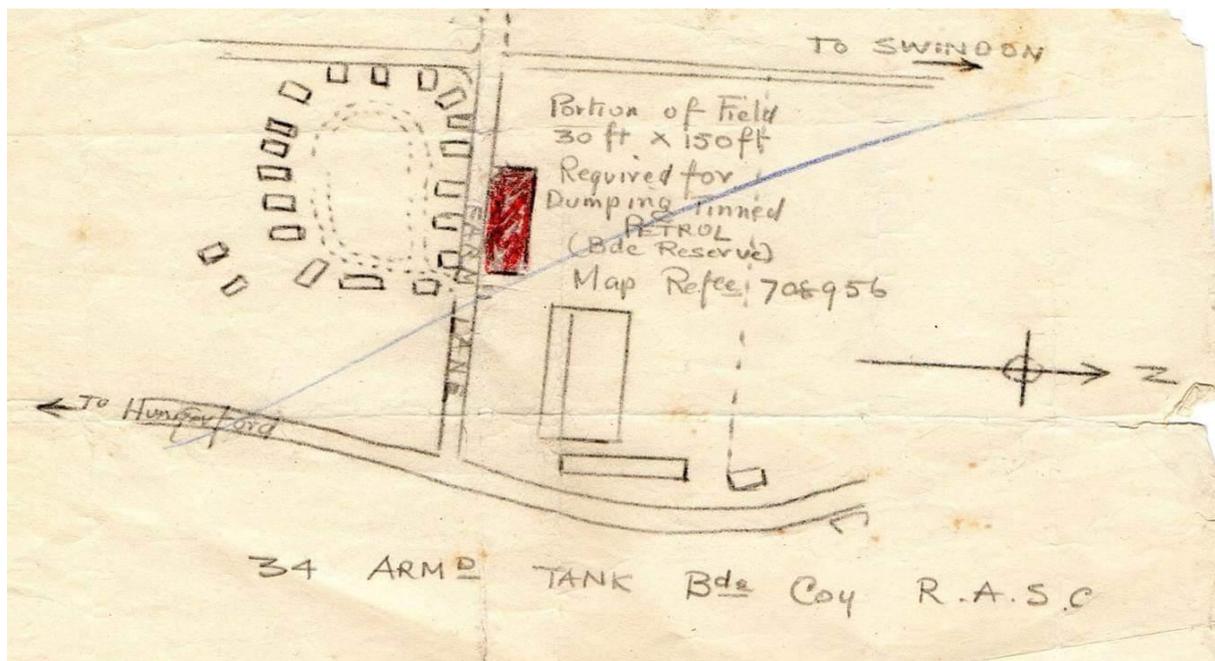
Fig 7: Royal Army Service Corps illustration of the Aldbourne Camp layout © Aldbourne Heritage Centre

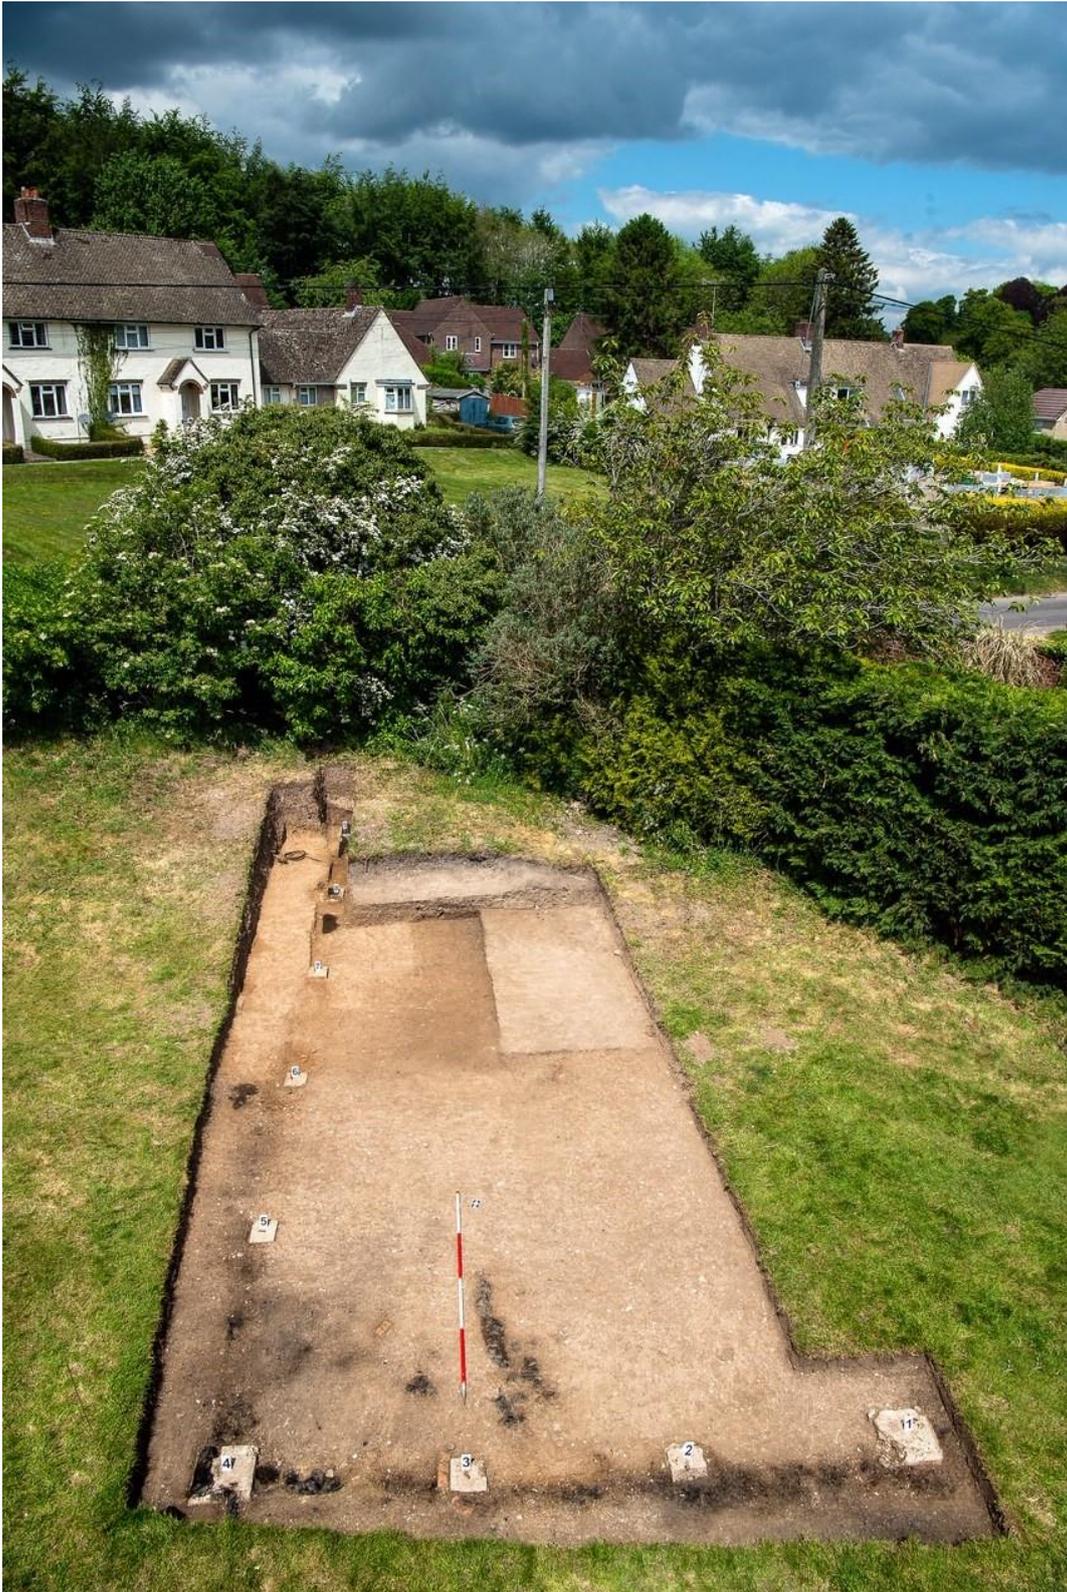
Fig 8: Trench 1 – Aldbourne 2019 showing the extent of the hut. Note the dark staining of the tarpaper between the pier pads at the front of the hut. Post pads are numbered sequentially from 1 in bottom right (SE) corner in a clockwise direction. Note the darker linear staining in the foreground which is the remaining clinker/slag and tar-paper damp course. The entrance is between pads 2 and 3 at the front.

Surprisingly, given that much of the site had been demolished shortly after the war, a great deal still remained, and the project research design was able to be tested to the full. A small test pit was opened over a linear anomaly on the survey which was located just outside the line of 'huts'. This small excavation trench gave us the evidence for one of the many paths that would once have connected all the elements of the camp. Now reduced to a base layer of iron slag on which, we presume, concrete slabs had once been laid.

Similar foundations were present in the area of the hut we were examining, with slag and a small amount of sharp sand. Other components of the footings of this 'Quonset' hut soon were also

revealed. These were square pads of concrete with iron reinforcement over which the curved sheets of corrugated iron which formed the hut superstructure sat. Bitumen sheets of the damp-proofing course adhered to the pads and some bricks, with the occasional makers stamp, were also still in situ. The site also yielded copious quantities of corrugated iron, of roofing nails (often with the retaining plates used to hold the sheets of iron in place still in situ) and a range of brackets, nuts, bolts, screws and hinges. We found a quantity of safety window glass too which added to our understanding of the barracks.

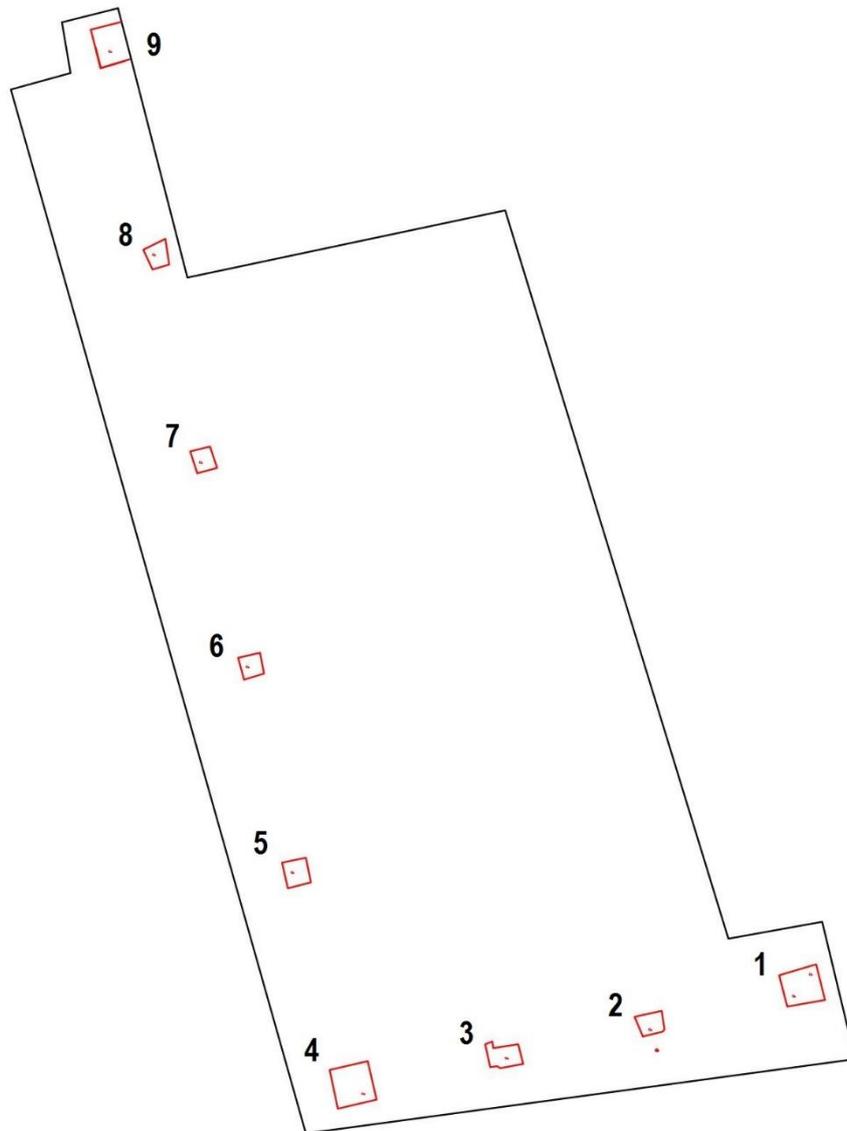
Fig 9: The Excavation Trench at Aldbourne 2019, with arrangement (and numbering) of post-pads and hence the alignment of the hut. The distance between the outer corner of pads 1 and 4 was exactly 16 feet (4.9m)

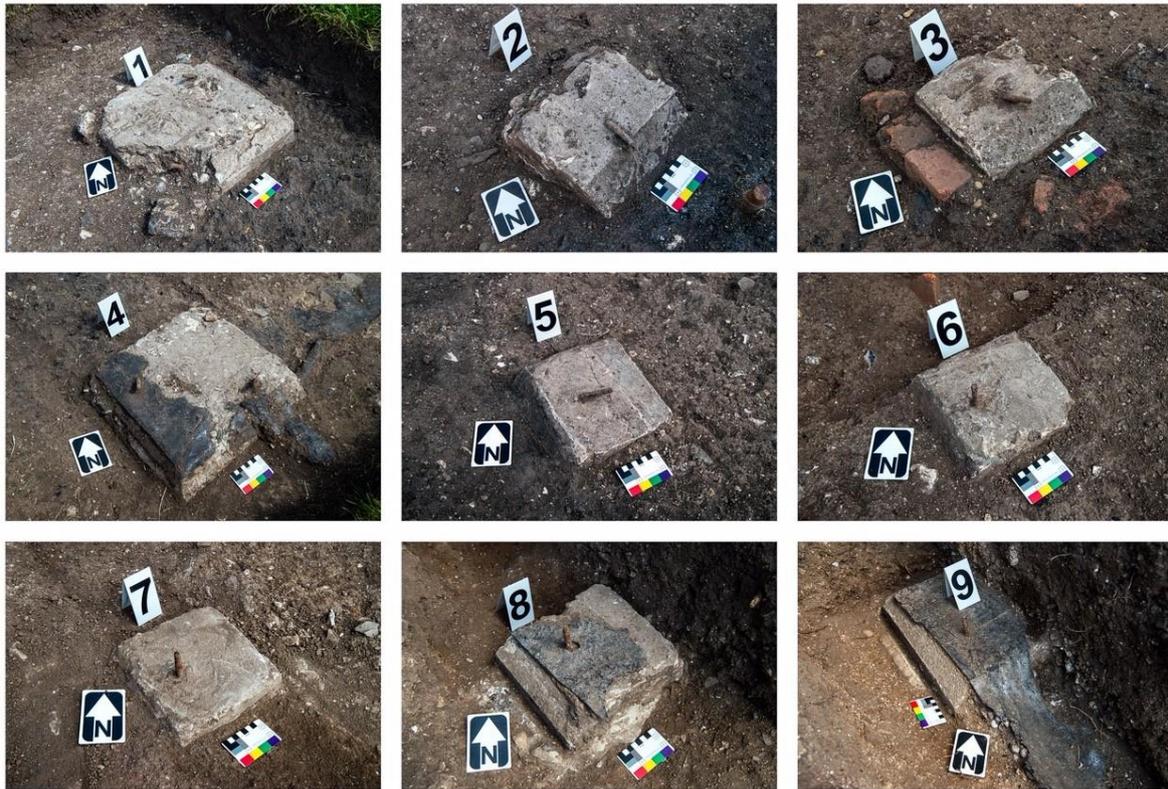
Fig 11: the nine pier pads excavated. These ran (from pad 1) the south east corner in a clockwise direction. Pads 1, 4 and 9 are corner pads.

Nine of the hut post pads were excavated to ensure we had both the maximum width and length of the structure exposed. The hut would have had 16 pads in total (Four on the long axis, two on the width, and four corner pads). The outer faces of all of the pads were sloped. Examination of pads 3 and 6 showed the former to be 9 inches deep, and the latter 8 inches. There was a small sandy layer on which pads 1-4 sat and with tar paper up and over the pads.

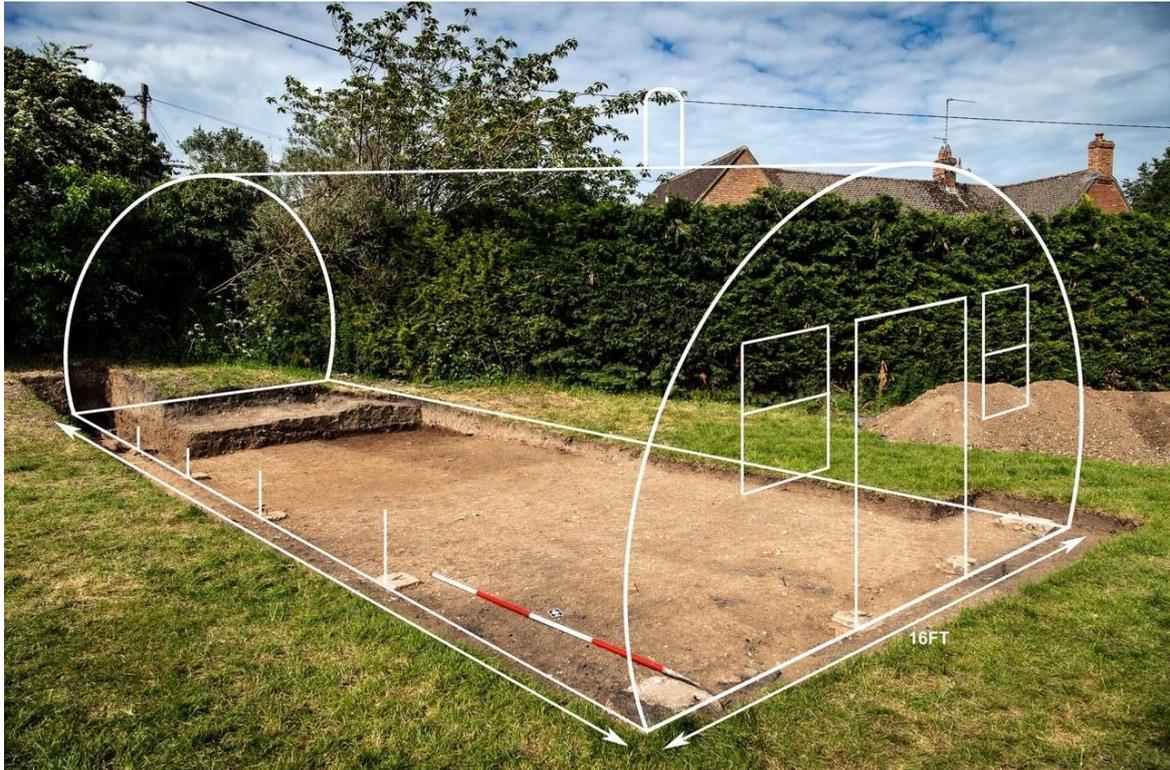
Fig 12: Layout and dimensions of the Nissen hut excavated at Aldbourne.

From the layout of the pads, and with plans of the building and the photograph held by the family of Sgt Carwood Lipton showing the Sergeants of Easy Company outside this building, we were able to formulate a depiction of the hut on these standings. The sole surviving hut in Aldbourne of this period, the Red Cross hut owned by Stephen Sowerby, also gives further detailing on the methodology of construction. Many of the components relating to the hut were also located; from roof screws and retaining plates through to corrugated superstructure material.

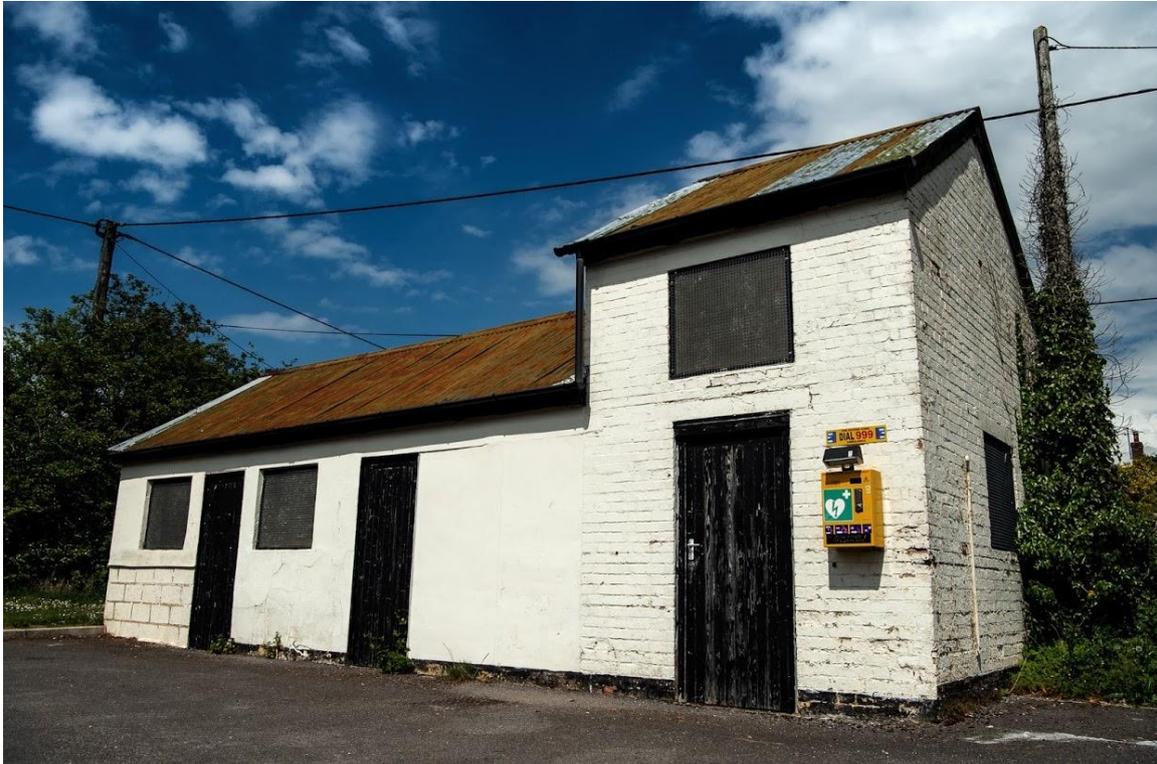
Fig 14: The Cookhouse showing the distinctive differences in the building.

The lower in height north western section is constructed of rendered cinder blocks and is 7.65m in length by 2.25m high. It has two doors and two windows and is covered by a corrugated iron apex roof. The cinderblocks on the northern end have been replaced by concrete blocks and a window on the southern end (near to where it joins the brick built structure) has been blocked in.

of the building has been blocked up. A number of internal modifications have been made to the building, including a partition wall that partly covers this blocked up entrance. The main part of the cinder block section of the buildings has been significantly modified with more partition walls creating two changing room spaces and original doorways and windows have been blocked up.

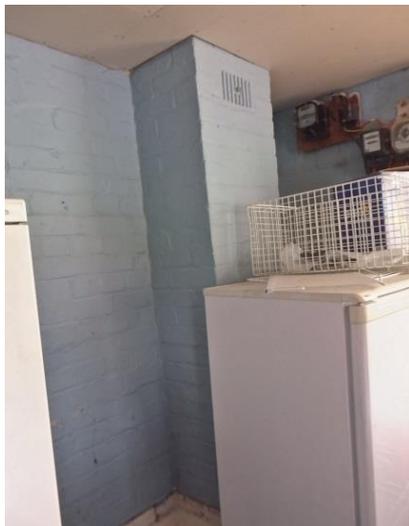
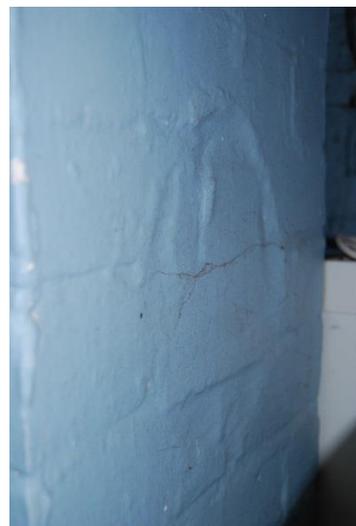
Fig 15 and 16: inside the cookhouse showing the chimney breast with air vent and blocked up stove pipe entrance. A boiler or stove was located here with a water tank above in the roof space.

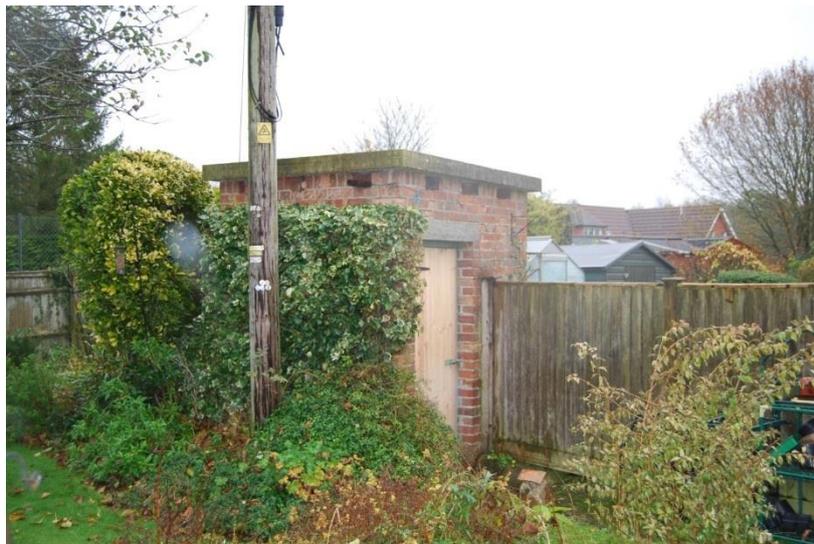
Fig 17: Pumping station showing the ventilation gaps just under the concrete roof.

Attached to the bottom part of the eastern elevation of the building is a small brick and concrete capped structure. The low platform type structure measures 1.75m in length, is 1m wide and 0.5m high.

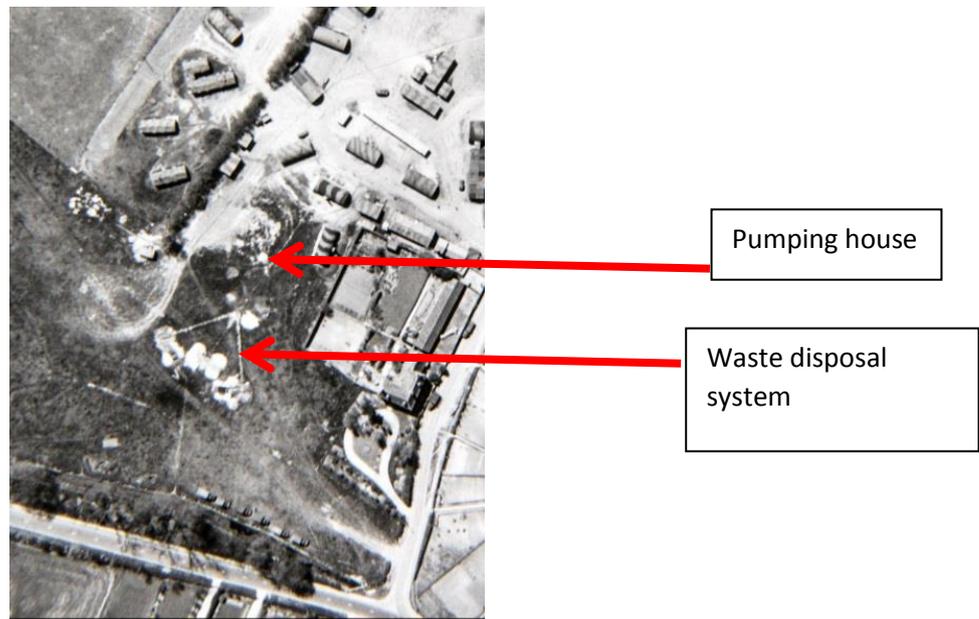
Fig 18: the disposal system is evident in the aerial photograph

The 1942 aerial photograph shows the pumping station near to an area of recent disturbance and construction. This area has been interpreted as the site of the waste disposal system, with potentially various cess pits or other flotation type tanks. The outline of lines (drains) lead to this area from some of the central camp buildings, which have been interpreted as latrines and ablution blocks.

This waste disposal system was probably just for greywater waste from the cookhouse, showers and ablutions as the latrines, according to US soldier accounts, were described as being “honey buckets” that were cleaned out and disposed of by a civilian contractor (Webster, unpublished).

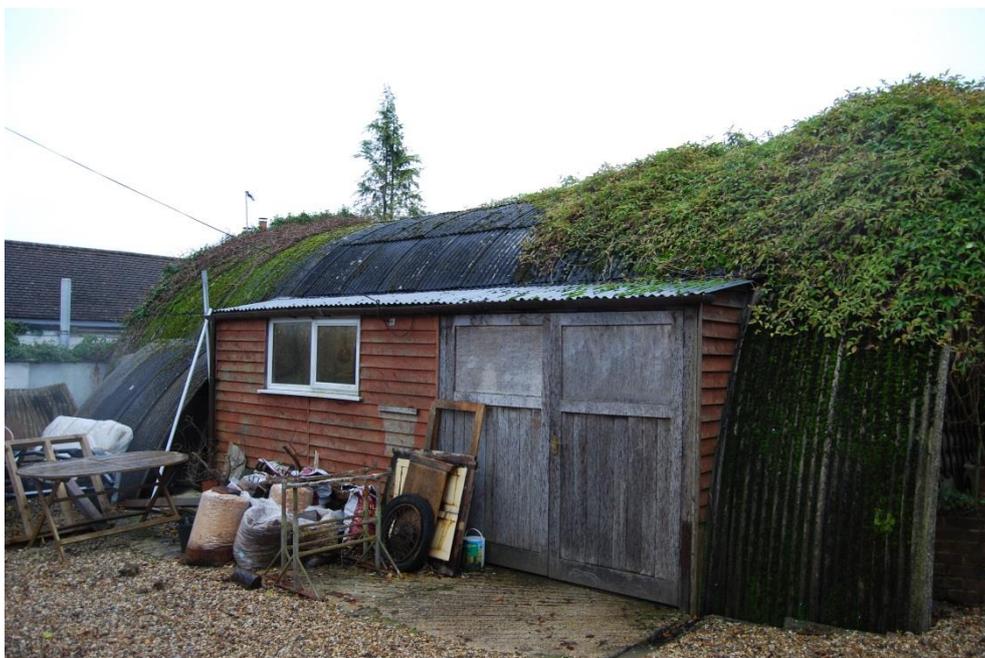
Fig 19: Photo of the outside of the Nissen hut

The Nissen hut measures 11.0m in length and c. 7.8m in width (internal cladding dimensions). It is a prefabricated half-cylindrical steel structure that is covered in curved corrugated asbestos sheeting. Its main facade has a central entrance that protrudes from the main elevation. The entrance has been modified. The steel structure of the hut is made up of four individual frames comprising of three curved steel ‘T’ shaped ribs (3.5m length) bolted together. These are connected to the other frames by 10 horizontal steel bars that are spaced out in intervals of 1.2m, from the base of one side to the other. The frames of each section are 3.65m apart. The inside of the hut has been converted into a workshop and has wooden cladding. Apart from the steel frame, no original features or fittings have survived.

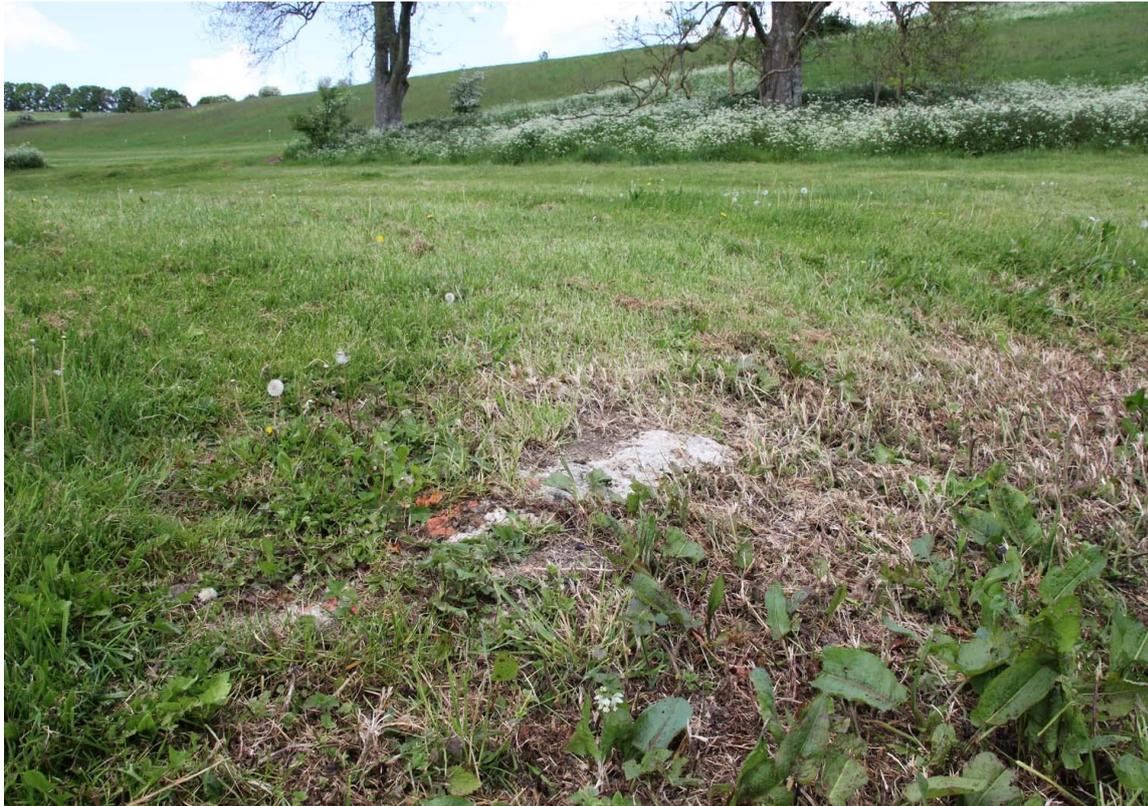
Fig 25: Foundations of the farmhouse at Pentico Wood.

The location of the farm buildings is indicated by an area of levelled land and small traces of brick work, potentially part of the foundations or construction material of the buildings. A circular depression on the ground was also seen which has been interpreted as the site of a well. The rest of the site is covered in grassland and there are no other surface features visible indicating the existence of the buildings.

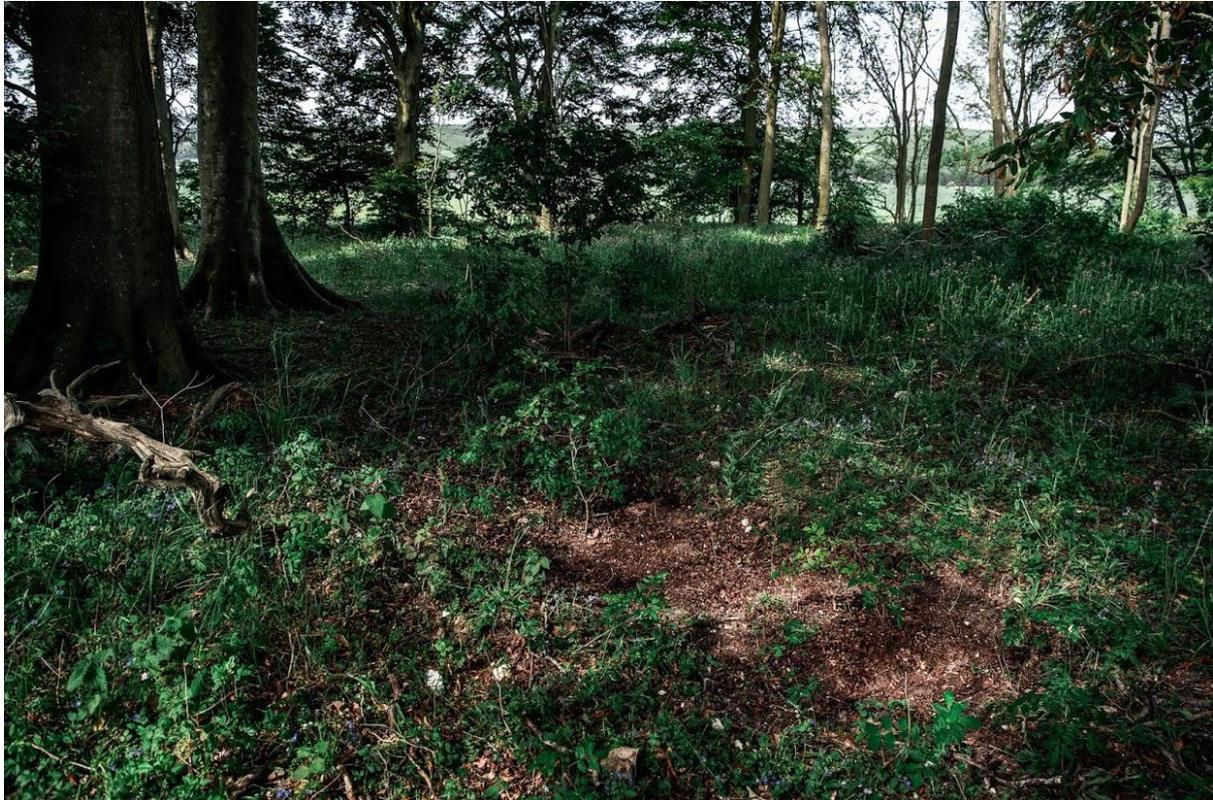
Fig 30: Photo of foxhole

In addition to the arborglyphs found, two two-man foxholes, and three potential foxholes, have been found in the same area of the woods. The two foxholes, measure c.2.2m by 1.1m and have a depth of c. 0.2m.

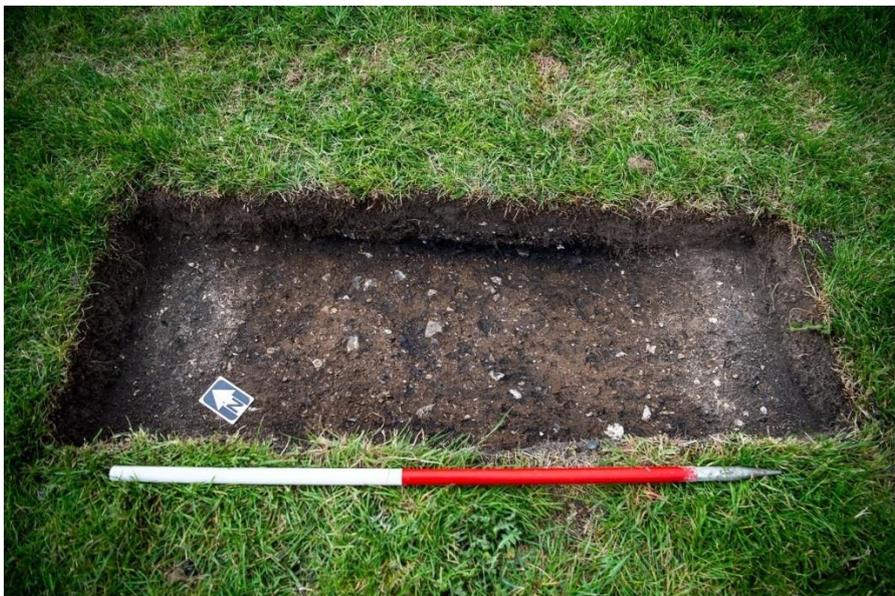
Fig 31: the test pit opened in 2019 to evaluate readings on the geophysical survey. Note the central strip which is the cinder sub-strata of a path (Layer 007) which ran in front of the various huts.

The ground truthing of geophysical survey was a real success; with the test pit we were able to establish that the anomaly was a layer of material that formed the foundation sub-strata for the paths of the camp. This can also be examined in future work. There were no paving slabs seen to be still in place over any paths so the signals present on the geophysical survey can be related to foundations materials. The layout of the hut examined precisely followed the interpretation of the air photographic plot and the geophysical survey. Thus, laying out excavation trenches over correct locations, and predicting which are likely to have surviving components, should be easily accomplished. Furthermore, the individual pier pads were visible in the survey helped, in part, by the presence of the iron reinforcement bars within them.

007 – cinder layer of a presumed path within the test pit, this was c94cm wide and 8cm thick and was a sub base for the path. We presume that concrete slabs formed the path and there is anecdotal evidence for these being removed and used as hard core in the repair of the village pond. It seems that the path was dug down through the field surface to ensure slabs were flush with this.
